IOWA DEPARTMENT OF NATURAL RESOURCES  
CONSTRUCTION DOCUMENTS

FOR  
LODGE REPAIR

AT  
AA CALL STATE PARK  
KOSSUTH COUNTY, IOWA  
D1FY19-1

PROJECT #19-02-55-01  
PLANS PREPARED BY  
LAND AND WATERS BUREAU  
CONSERVATION AND RECREATION DIVISION

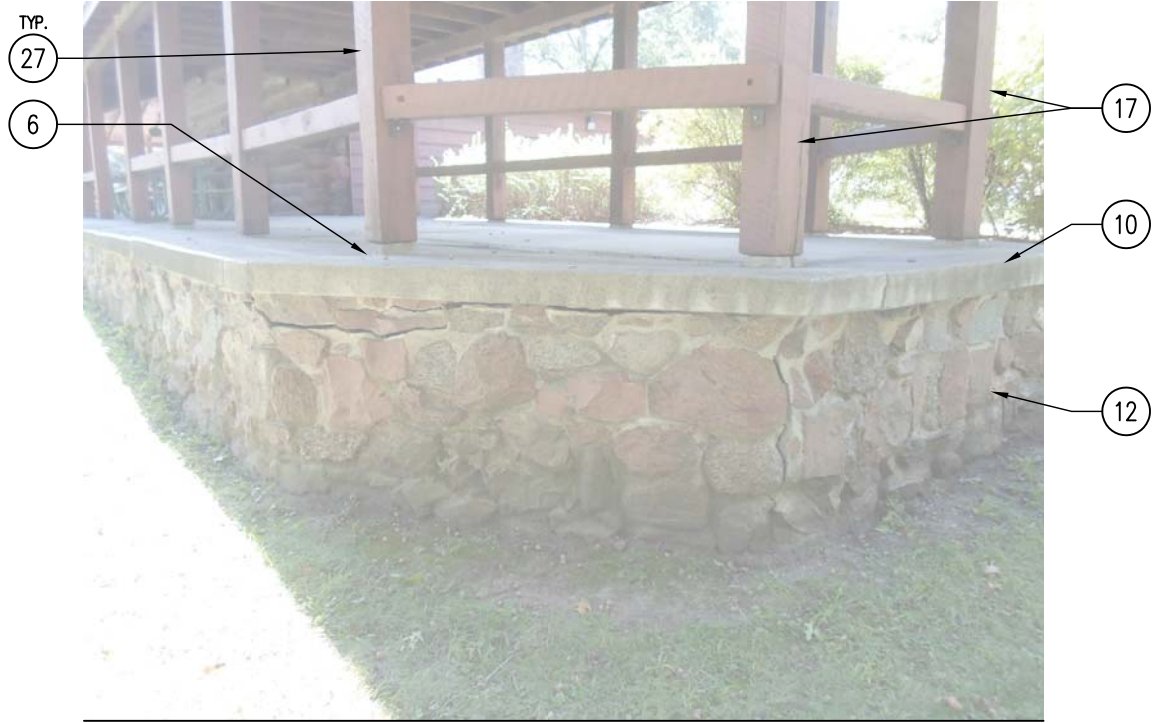
04 BREEZE-WAY PICTURE - SLAB, WALL, AND COLUMN  
SCALE: NTS

CONCRETE PATIO TO BE REPLACED IN REAR OF THE BUILDING, CONCRETE TO BE 4" PCC OVER 6" OF SUBBASE, WITH #4 EPOXY COATED REBAR 24" O.C. BOTH DIRECTIONS. CONCRETE TO BE DOWELED INTO EXISTING SLAB AS SHOWN. THE CONTRACTOR SHALL ALSO REPLACE TWO (2) COLUMN FOOTINGS IN THE BREEZE-WAY AREA AS SHOWN.

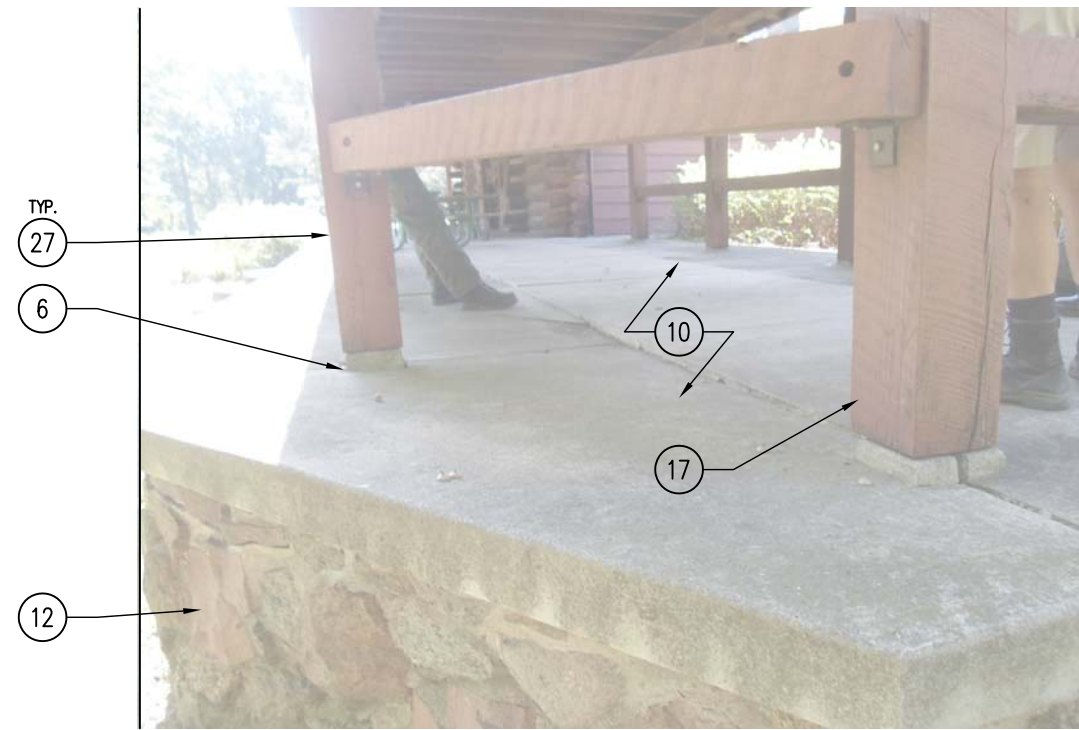
03 BREEZE-WAY PICTURE - SLAB, WALL, AND COLUMN  
SCALE: NTS

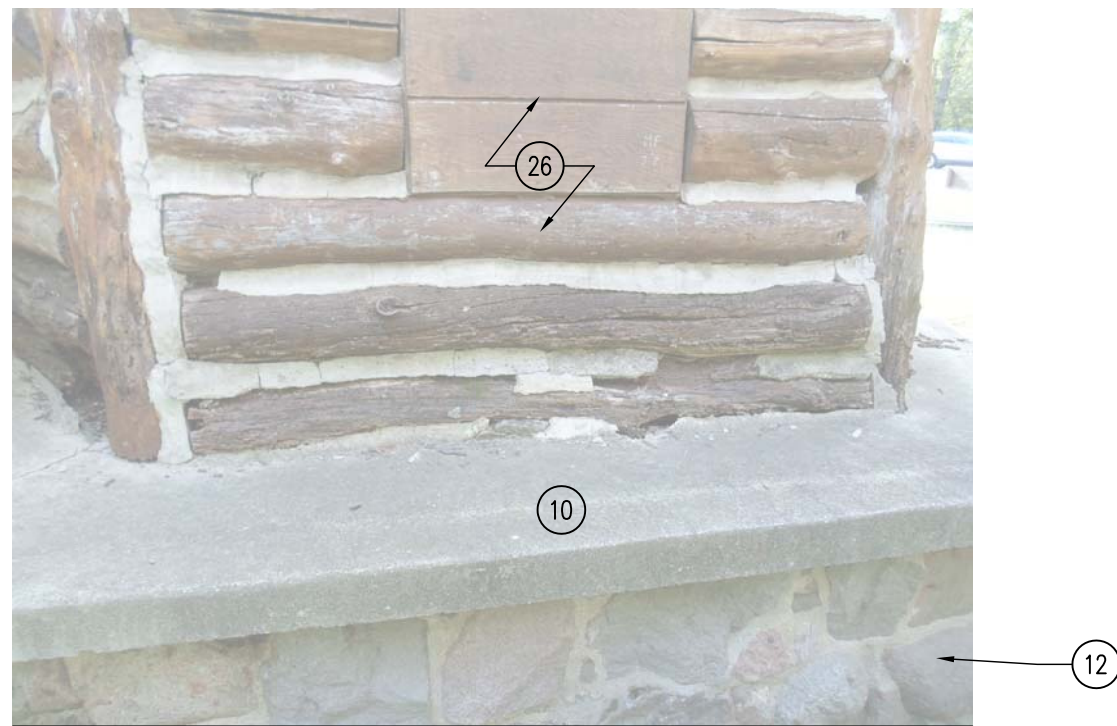
02 PUMP HOUSE PICTURE - SLAB, WALL, AND LOGS  
SCALE: NTS

CONTRACTOR SHALL REBUILD ENTIRE PUMP HOUSE WITH NEW, SEASONED, WHITE OAK LOGS OF SIMILAR DIMENSION TO EXISTING LOGS. A NEW PERIMETER FOOTING AND SLAB TO BE REPLACED AS WELL. ALL NEW CHINKING TO BE PERMA-CHINK, COLOR TO BE MEDIUM GRAY 224.

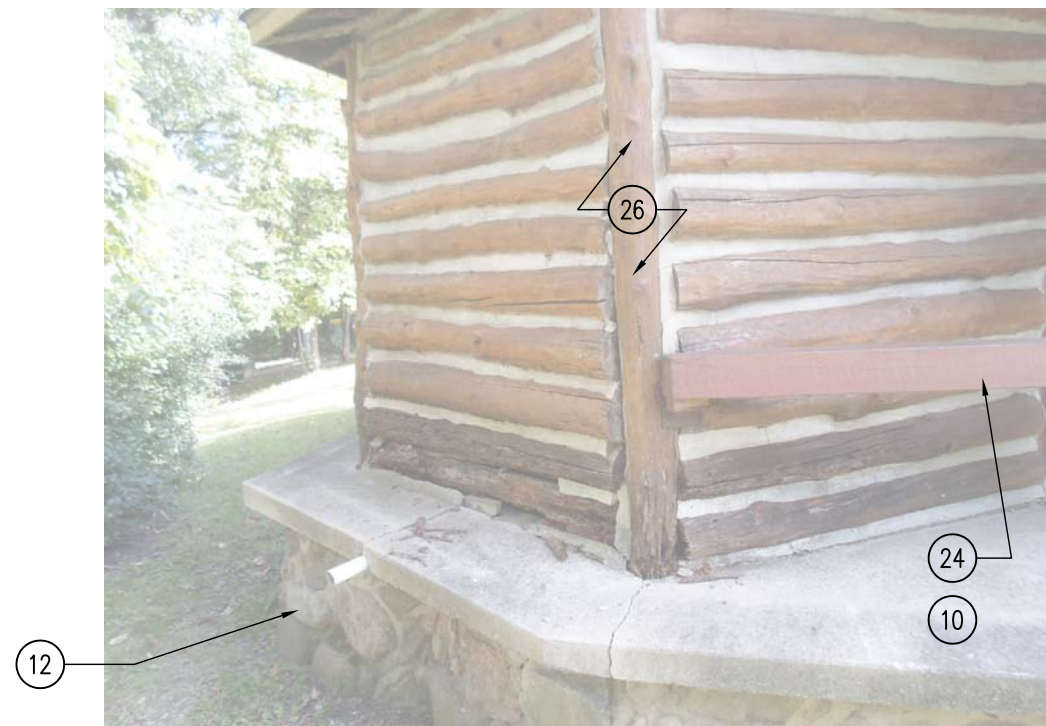
01 PUMP HOUSE PICTURE - SLAB, WALL, AND LOGS  
SCALE: NTS
