**Re: Fall 2021 Semi-Annual Inspection Report
Woodbury County Sanitary Landfill (Closed)
Permit No. 97-SDP-2-75C
Project No. WCASW 22001**

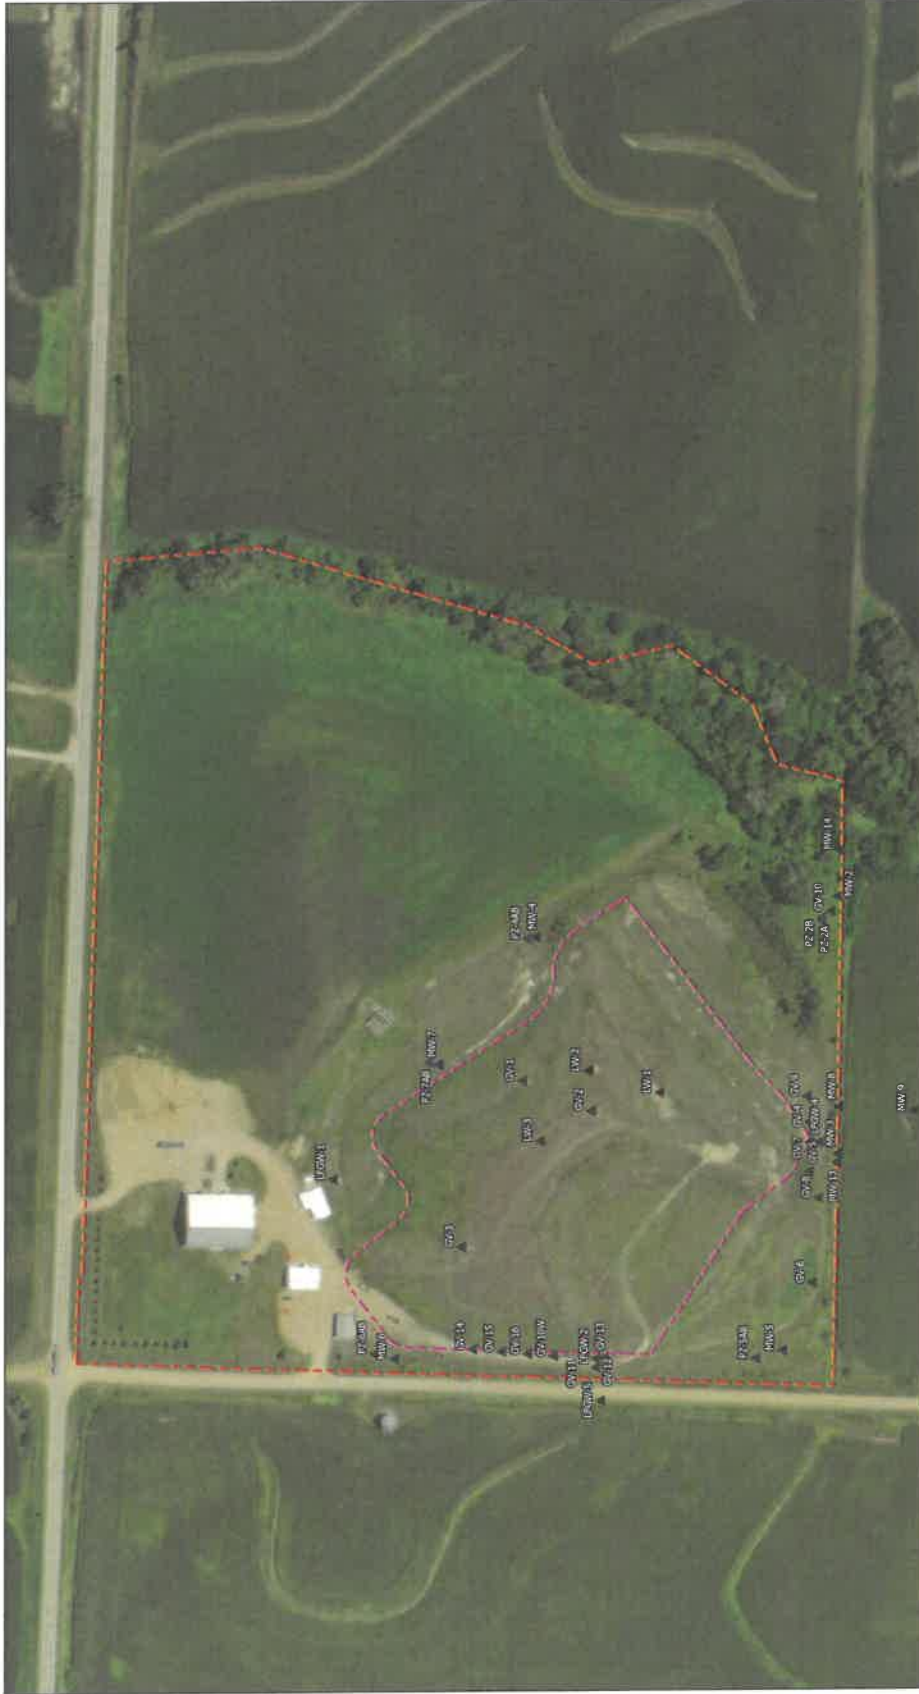
Woodbury County Landfill Site Map

Woodbury County Sanitary
Landfill
Pierson, Iowa
Project No: WCASW.21000
Drawing Date: January 2021
