Subject: 2025 Annual Inspection Report
Henry County Sanitary Landfill
Permit No. 44-SDP-01-75C

This report documents the annual inspection required by the Henry County Sanitary Landfill's (Landfill) Iowa Department of Natural Resources Sanitary Disposal Project Closure Permit and the Iowa Administrative Code. This inspection, conducted on March 20, 2025, by Timothy Buelow, P.E. of SCS Engineers, was performed to evaluate the Landfill's general conformance with the closure permit and the approved plans and specifications. A map of the Landfill is attached for reference (Figure 1). A copy of the observation checklist used during the inspection is included in Attachment A. This checklist provides a summary of noteworthy observations from the inspection.

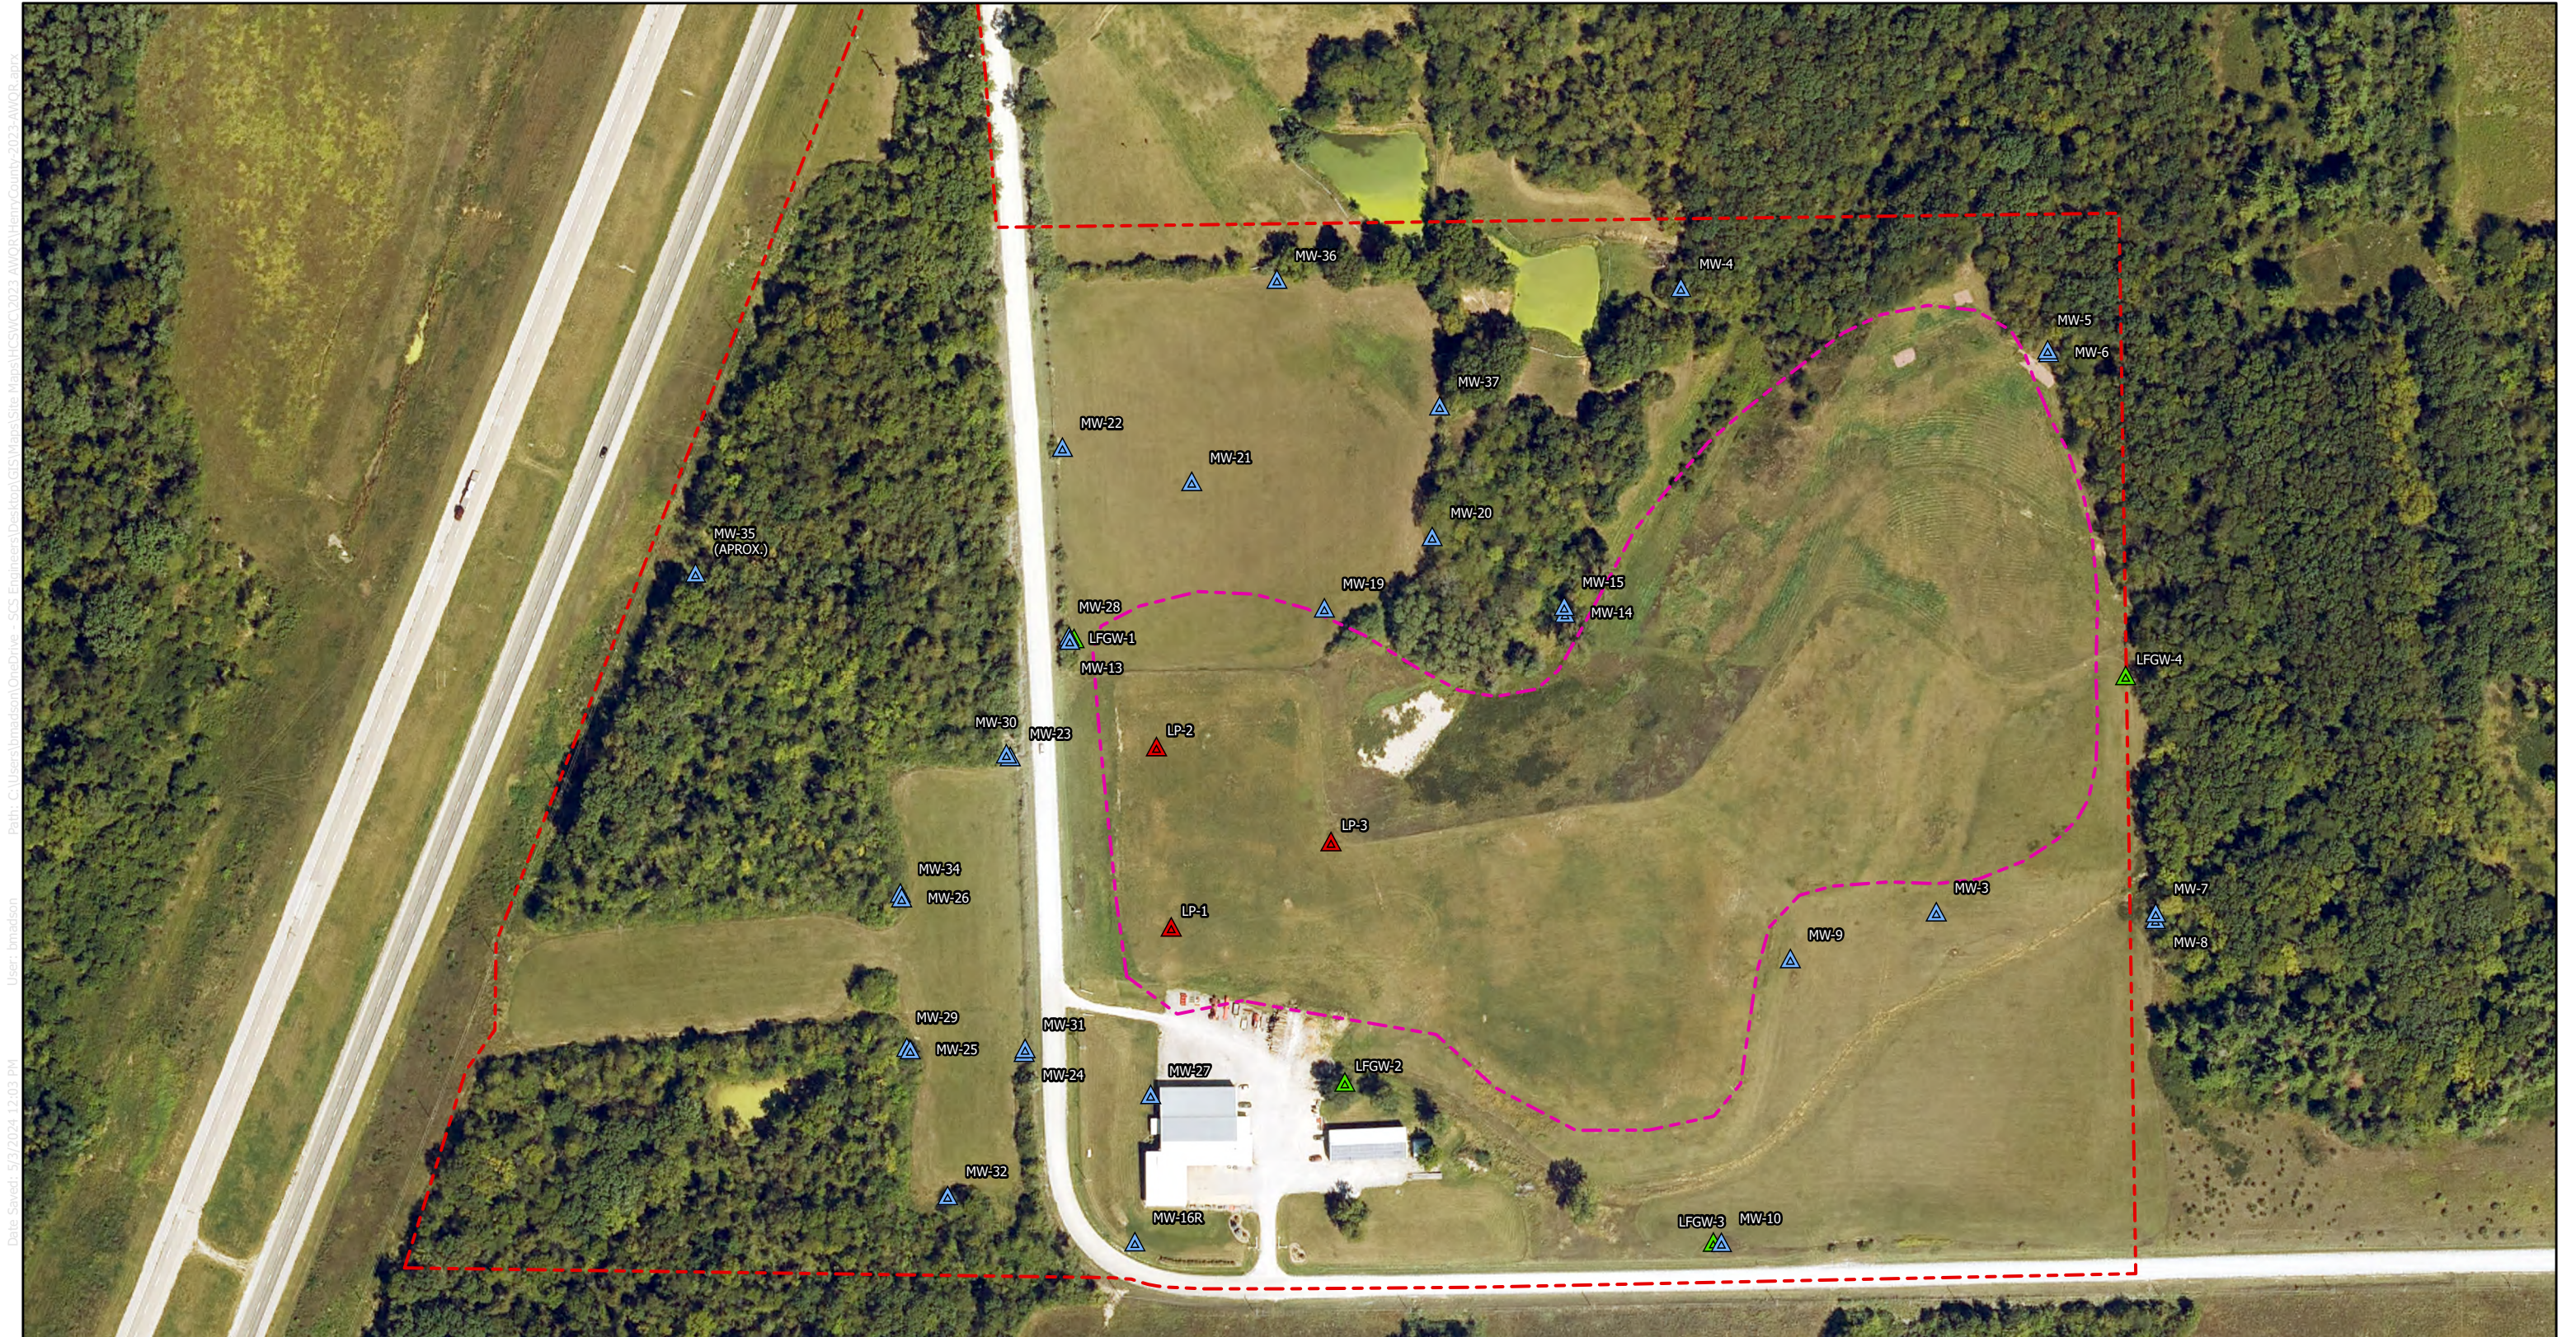
Figure 1

Site Map

- ▲ Approximate Monitoring Well Location
- ▲ Approximate Gas Monitoring Point Location
- ▲ Approximate Leachate Monitoring Location
- Approximate Waste Boundary
- Approximate Property Boundary

Henry County Sanitary Landfill
 Mt. Pleasant, Iowa
 Project No: 27224515.25
 Drawing Date: March 2025
