CCR North and South Surface Impoundments 2021 Annual Inspection Report Riverside Generating Station

MidAmerican Energy Company
Riverside Generating Station
Bettendorf, Iowa
February 22, 2022

MidAmerican Energy Company Riverside Generating Station CCR Surface Impoundments 2021 Annual Inspection Report

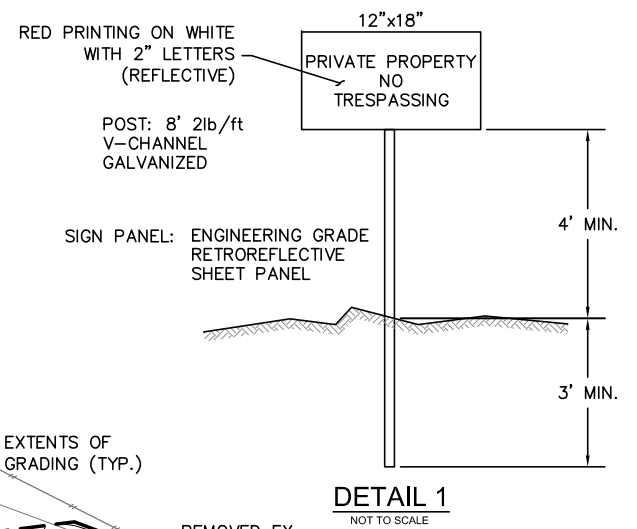
PROJECT NO. 111914
SHEET **D.03**

LEGEND: SUBGRADE TREATMENTS USED BELOW RCL, LISTED HIGHEST TO LOWEST ELEVATION

- - TENCATE PP105 (75x300 PRE-SEWN PANEL, OVERLAPPED BY 2' HEAT-WELD MELTED TOGETHER)
- - 8 OZ. GSE FABRINET 200 MIL GEOCOMPOSITE FABRIC
- - LIME STABILIZATION IN AT LEAST 1 LIFT
- - RIP RAP FOR STABILIZATION

PROJECT RIVERSIDE GENERATING STATION
SOUTH IMPOUNDMENT POND CAPPING
CLIENT MIDAMERICAN ENERGY COMPANY
SHEET **CLOSURE CAP PLAN**

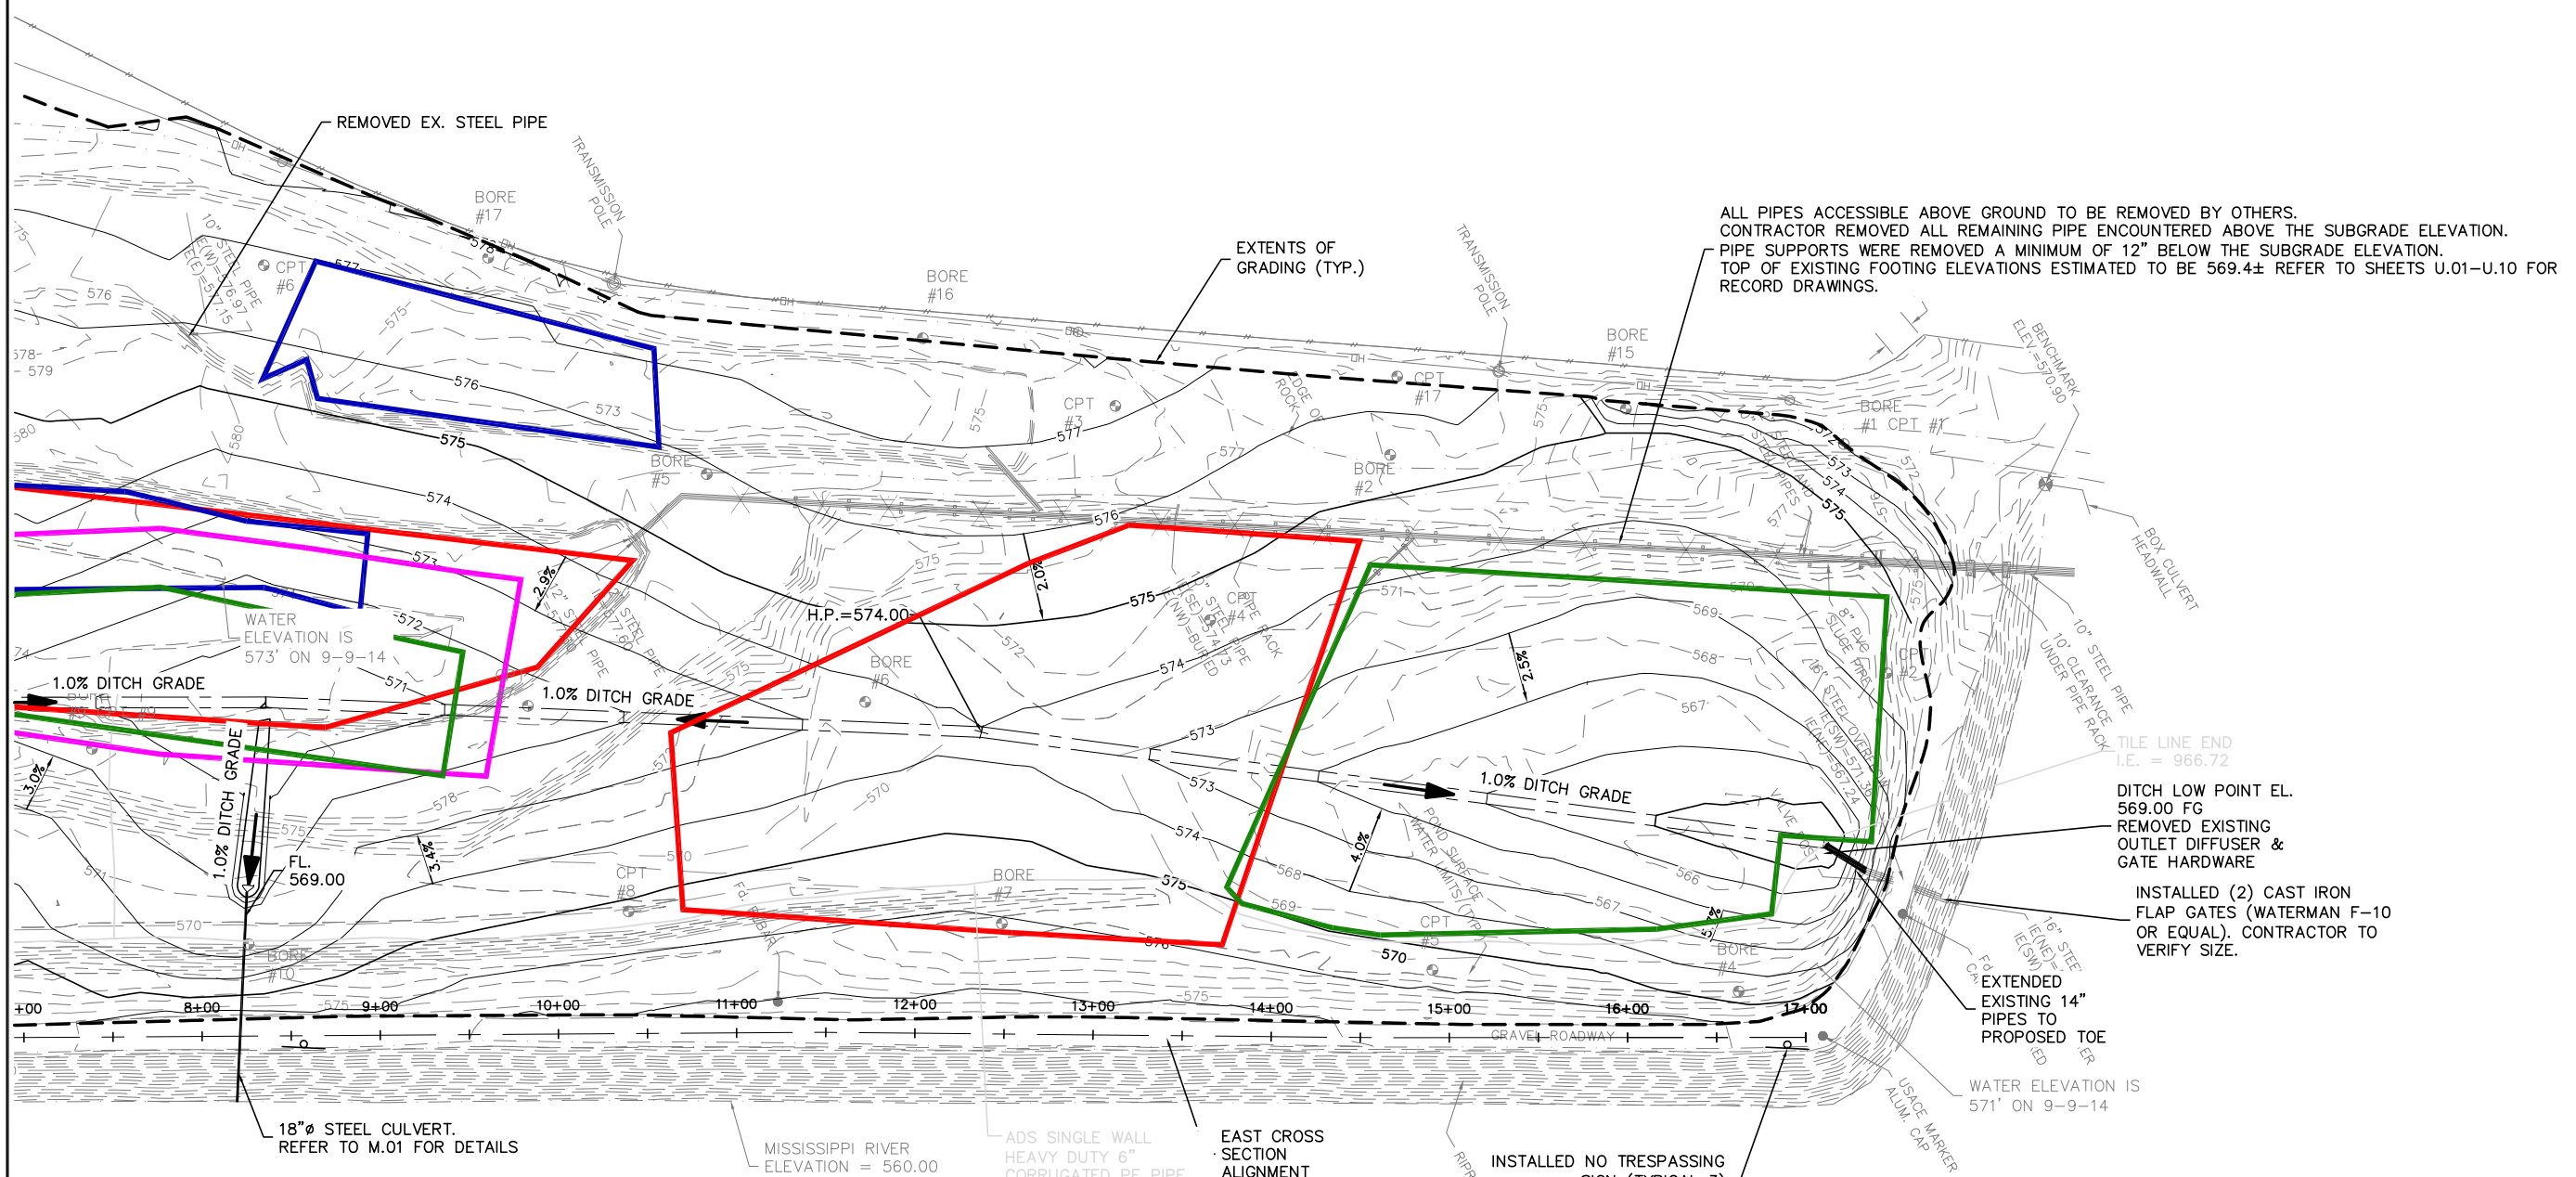
project no. 111914
sheet D.01

ALL PIPES ACCESSIBLE ABOVE GROUND TO BE REMOVED BY OTHERS. CONTRACTOR REMOVED ALL REMAINING PIPE ENCOUNTERED ABOVE THE SUBGRADE ELEVATION. PIPE SUPPORTS WERE REMOVED A MINIMUM OF 12" BELOW THE SUBGRADE ELEVATION. TOP OF EXISTING FOOTING ELEVATIONS ESTIMATED TO BE 569.4± REFER TO SHEETS U.01-U.10 FOR RECORD DRAWINGS.

DITCH LOW POINT EL. 569.00 FG
REMOVED EXISTING OUTLET DIFFUSER & GATE HARDWARE

project RIVERSIDE GENERATING STATION
NORTH IMPOUNDMENT CAPPING
client MidAmerican Energy Company
sheet CLOSURE CAP OVERALL PLAN
