## SCS ENGINEERS

Subject: Spring 2025 Semiannual Inspection Report

ADM Clinton Landfill (Closed) Permit No. 23-SDP-05-88C

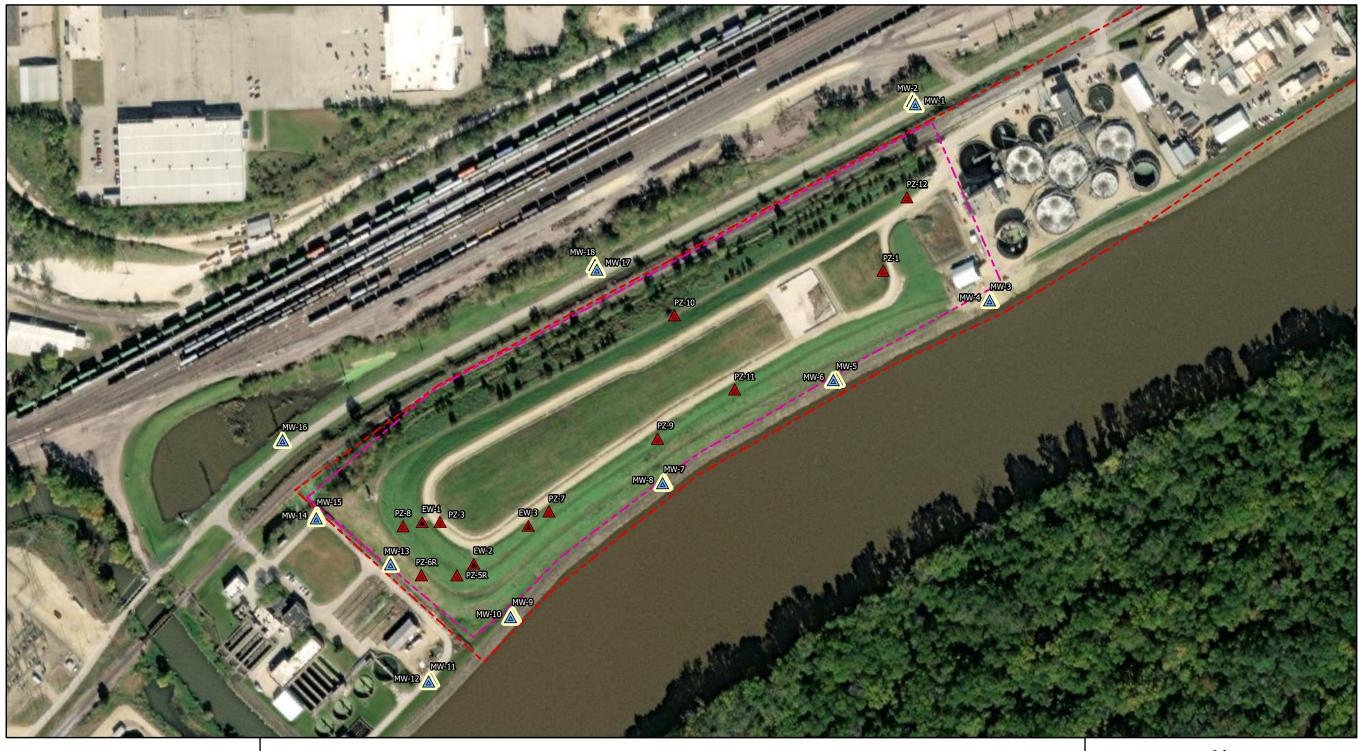
# Site Map

Encl. Figure 1 - Site Map Attachment A - Sanitary Landfill Inspection Checklist
