Subject: Spring 2025 Semiannual Inspection Report
Heidelberg-Mason City Cement Manufacturing Waste Landfill
Permit No. 17-SDP-08-99P

Heidelberg-Mason City
Cement Mfg. Waste Landfill
Mason City, Iowa
Project No: 27225178.00
Drawing Date: April 2025

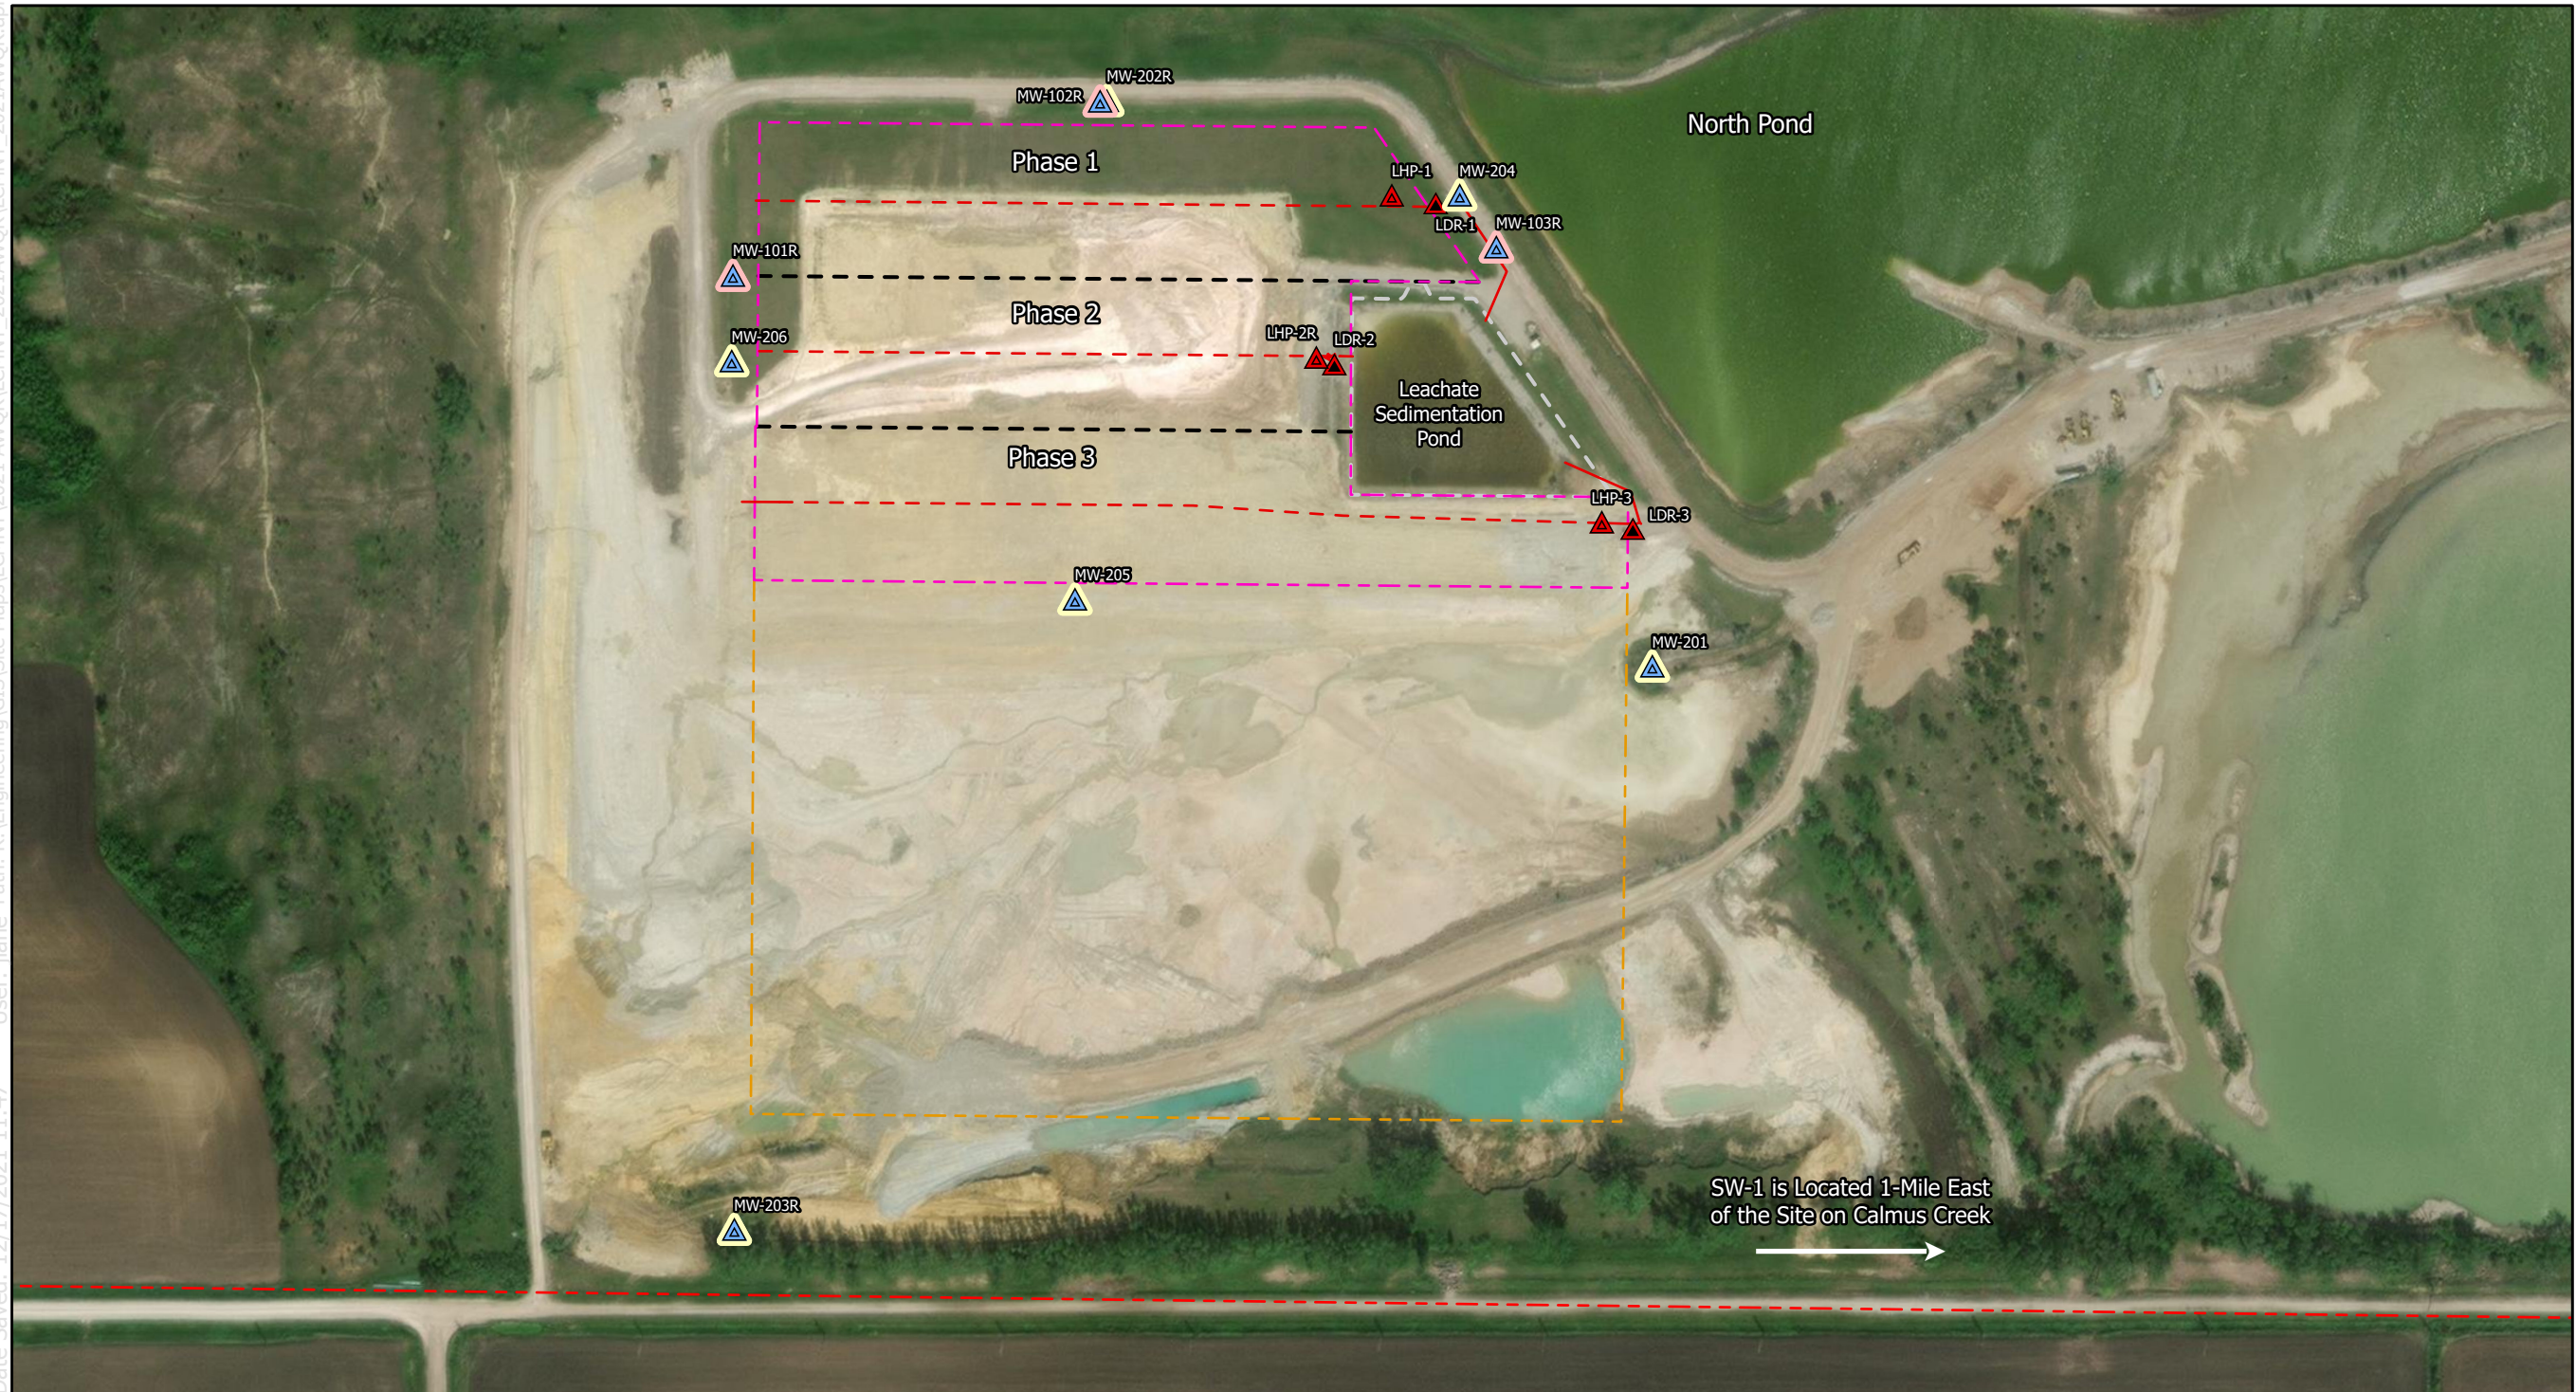
Site Map

Encl. Figure 1 – Site Map
Attachment A – Sanitary Landfill Inspection Checklist
