Subject: Fall 2025 Semi-Annual Inspection Report
Crawford County Area Sanitary Landfill
Permit No. 24-SDP-01-73C

Current Site Map

Crawford County Area
Sanitary Landfill
Denison, Iowa
Project No: 27224514.26
Drawing Date:
November 2025

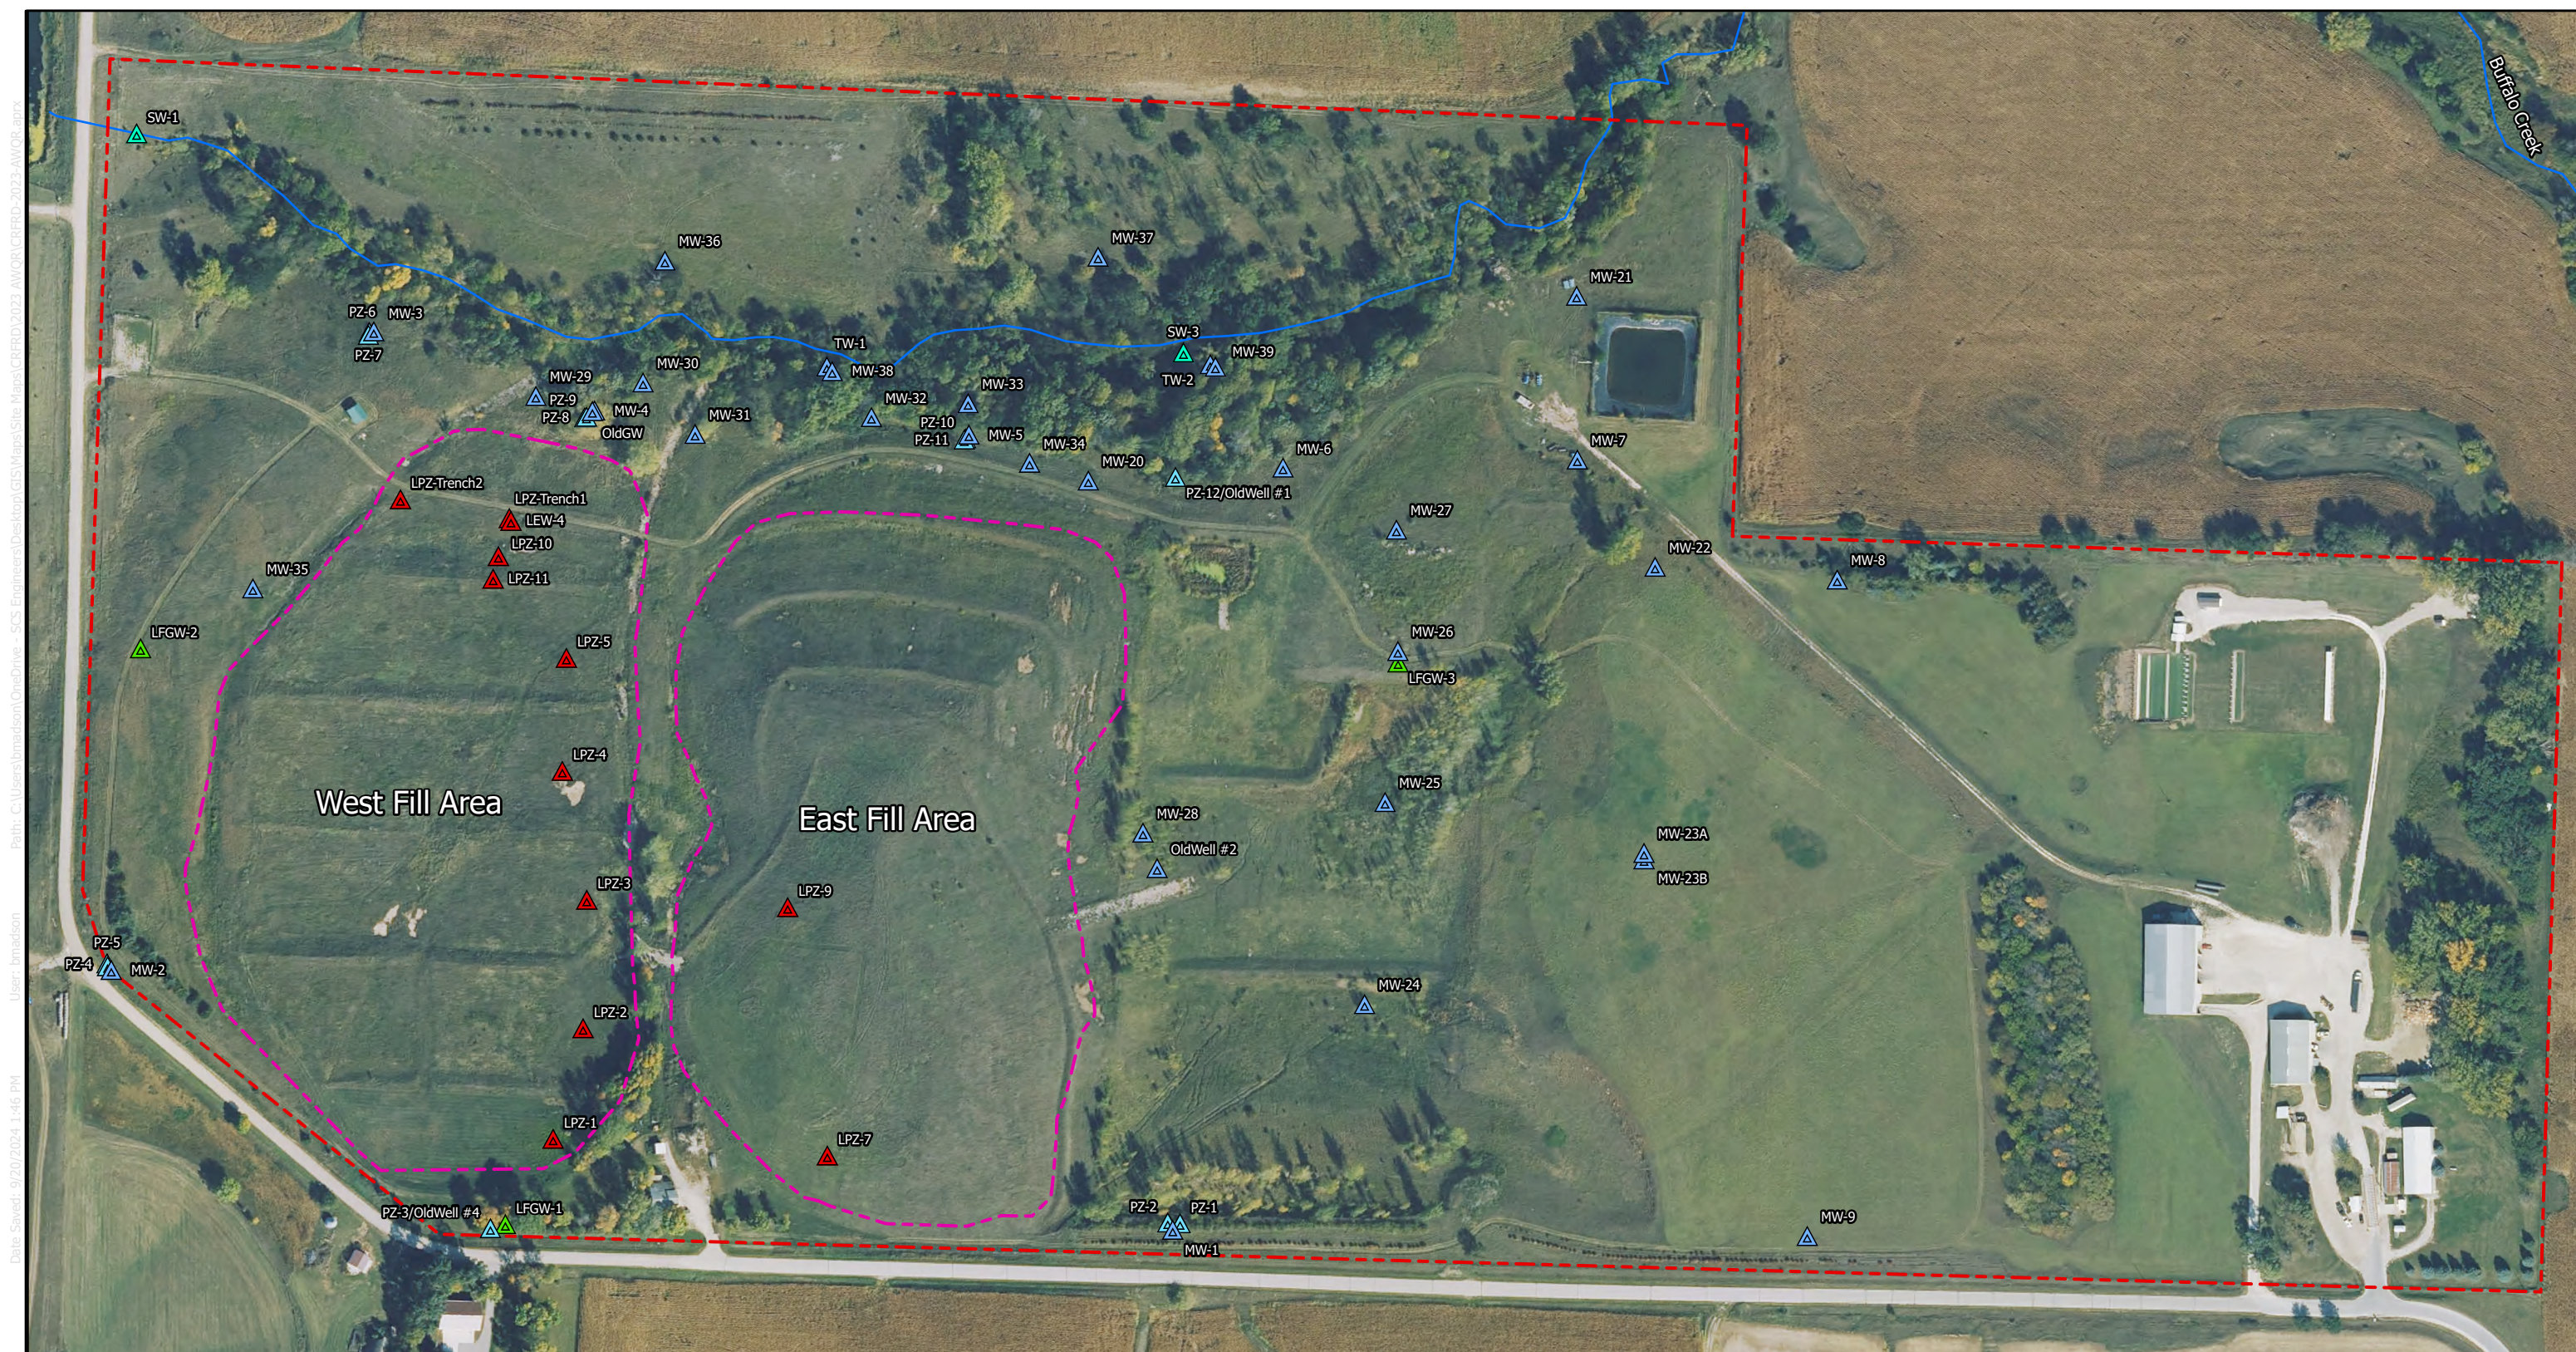
Figure 1

Legend	
Monitoring Well	Landfill Gas Well
Groundwater Piezometer	Approximate Waste Boundary
Surface Water Monitoring Point	Approximate Property Boundary
Leachate Piezometer	Stream
