SUBJECT: City of Clarinda WWTF Industrial Treatment Agreement  
Routine Inspection of Industrial Pretreatment Facility  
NPDES #7329001-IC2, Staff Action # 180272

**IOWA DEPARTMENT OF NATURAL RESOURCES  
INDUSTRIAL USER INSPECTION**

**FACILITY NPDES # 7329001-IC2**

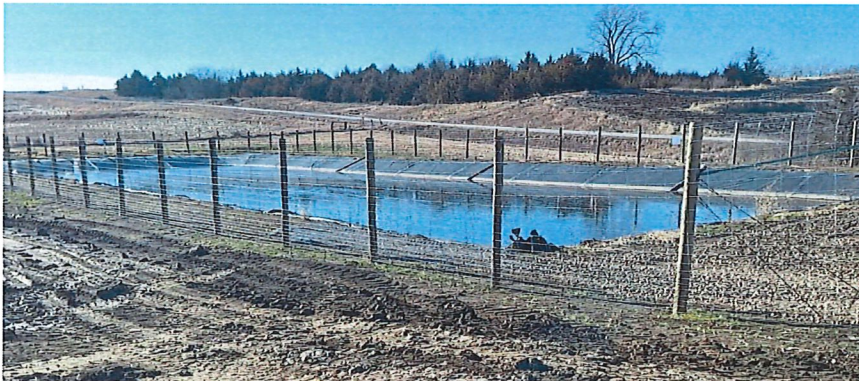
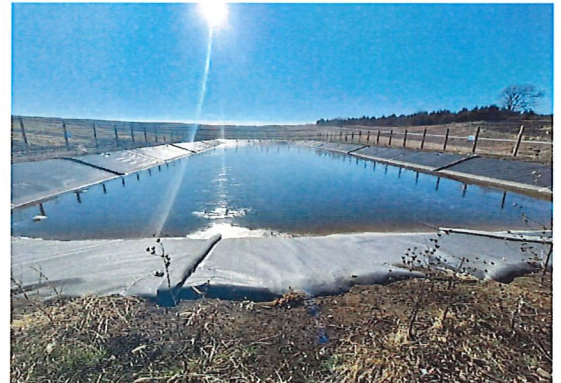
The Page County Landfill leachate lagoon is secured within the confines of the landfill property and includes a fence and locked gate. A single lagoon receives leachate from all landfill cells. According to Mr. Ward, the cell can hold 770,631 gallons of leachate. The lagoon is synthetically lined and will have an EcoMister Evaporator added in the Spring 2025 that will aid in reducing the leachate that will need to be hauled in the future. During the inspection the lagoon appeared to have enough freeboard. Freeboard is measured from the maximum liquid level to the top elevation of the lagoon berm/wall. Continue to ensure that a minimum of 2 feet of freeboard is maintained in the lagoon to prevent overflow and bypass events.

As we discussed, keeping trees or woody vegetation out of the lagoon area is required. If trees and woody vegetation are allowed to grow, their roots may damage the lagoon's liner and the integrity of the lagoon. Additionally, although the lagoon is synthetically lined, any burrowing animals should be eliminated. The photos below document our observations.

Photos 1-2: New leachate lagoon cell

- Fill burrows as they are encountered around the lagoon.
- Continue inspecting the abandoned lagoon.
- Report all bypasses within 24 hours
- Comply with all monitoring and reporting requirements specified in your NPDES operation permit. [ 567-63.9]

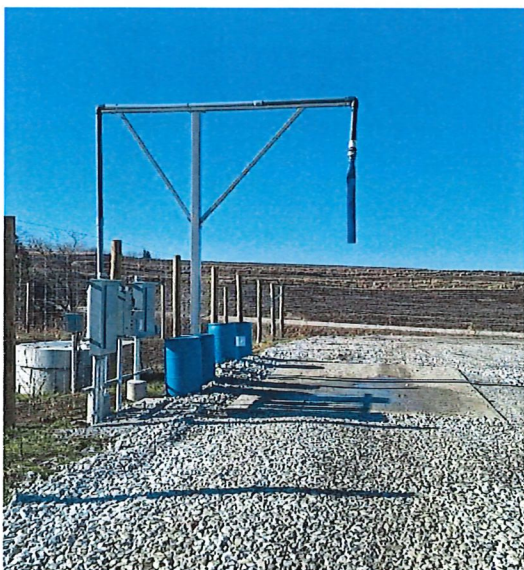
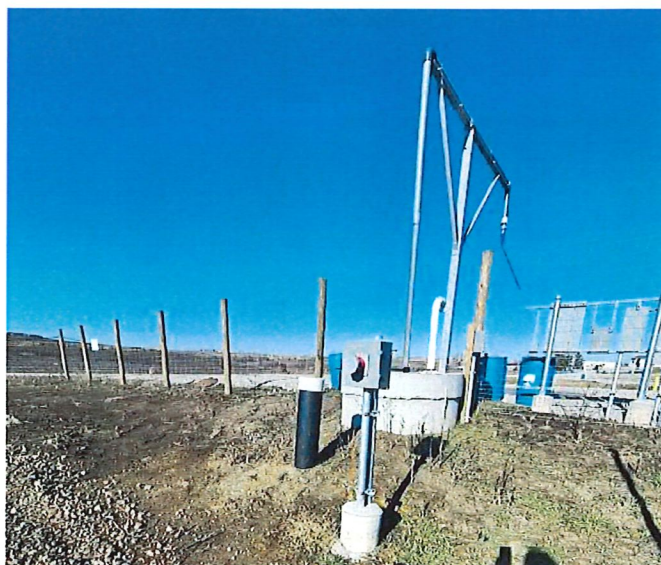
According to Mr. Ward, typically the landfill hauls two loads of leachate weekly. Due to an increase in precipitation this year, Mr. Ward is hauling more leachate presently to lower the lagoon depth in preparation for the winter months.

Photos 3-4: Leachate loadout area

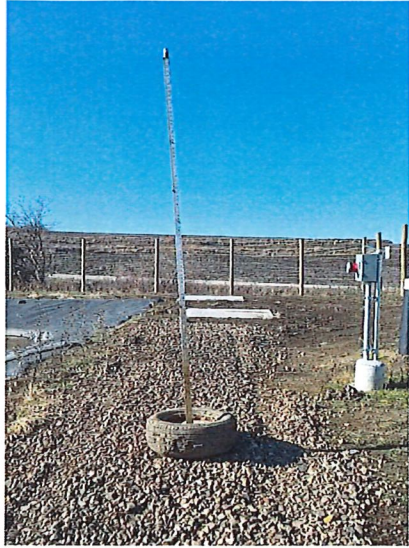
Mr. Ward stated the cell depth measuring device was pulled out for the winter, but will be placed in the lagoon again in the spring.

Photo 5: Cell depth measuring device

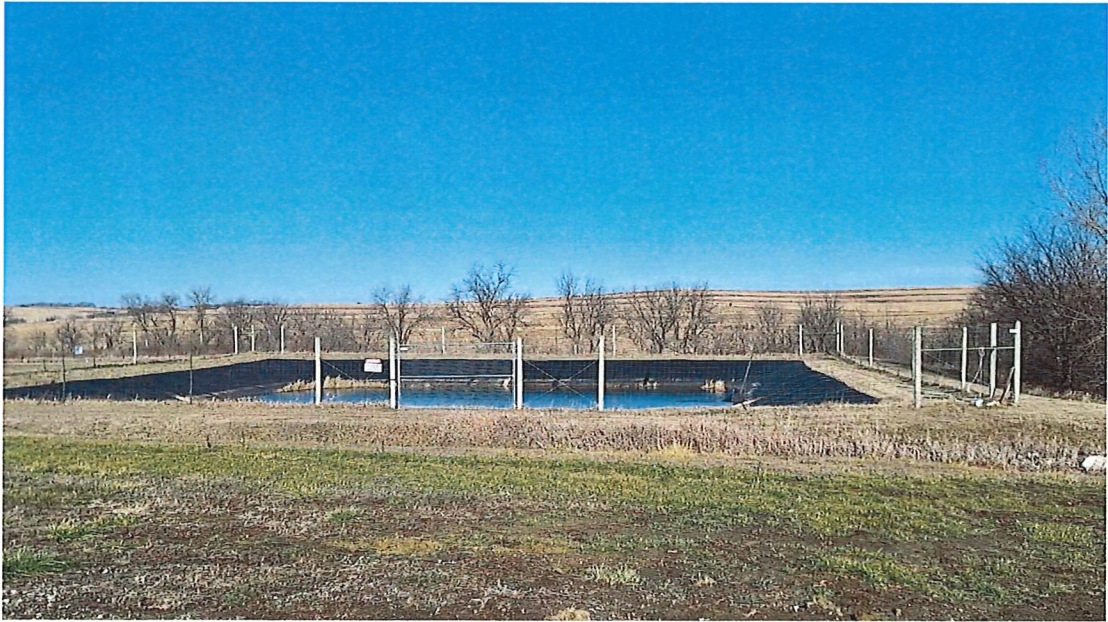
The Page County Landfill also maintains an old leachate lagoon. Although no leachate flows to this cell any longer, Mr. Ward was advised to maintain this cell in the event it is needed. We did not observe any issues with this lagoon cell. Although the lagoon is no longer used, continue to monitor and inspect it for signs of erosion, animals burrows, and trees. The photo below documents our visual observations.

Photo 6: Old leachate lagoon

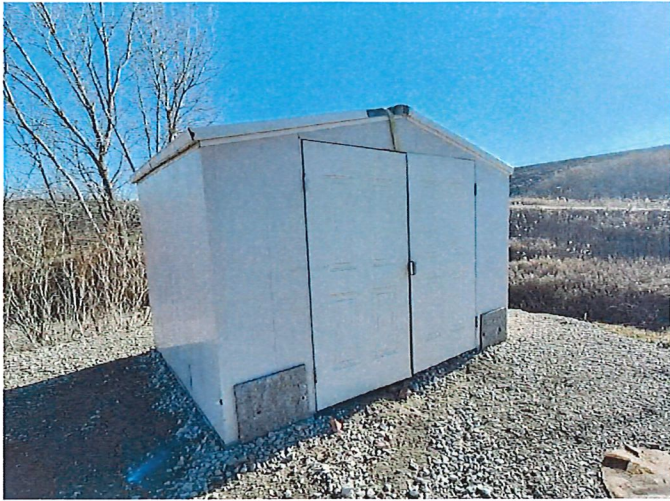
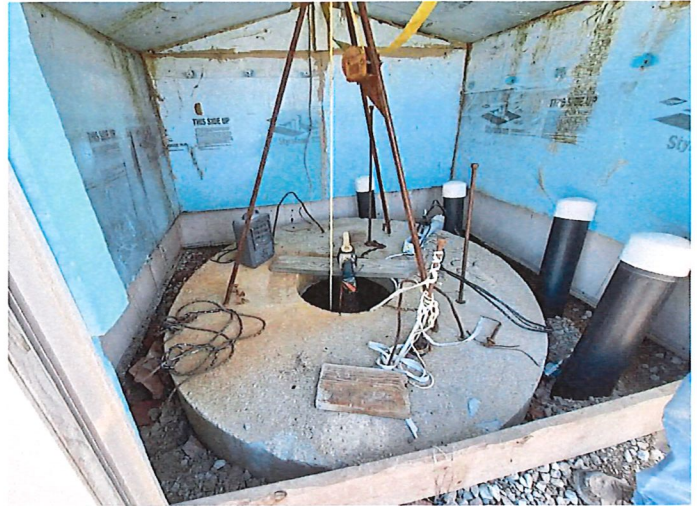
As discussed above, leachate from the older cells flows via gravity to a wet well where it is pumped to the top of the hill and then gravity flows to the newly constructed leachate pond. It is recommended that the pumps be calibrated per the manufacturer's recommendation to ensure they continue working properly. Observations of the wet well photos are below.

Photos 7-8: Wet well near old leachate lagoon

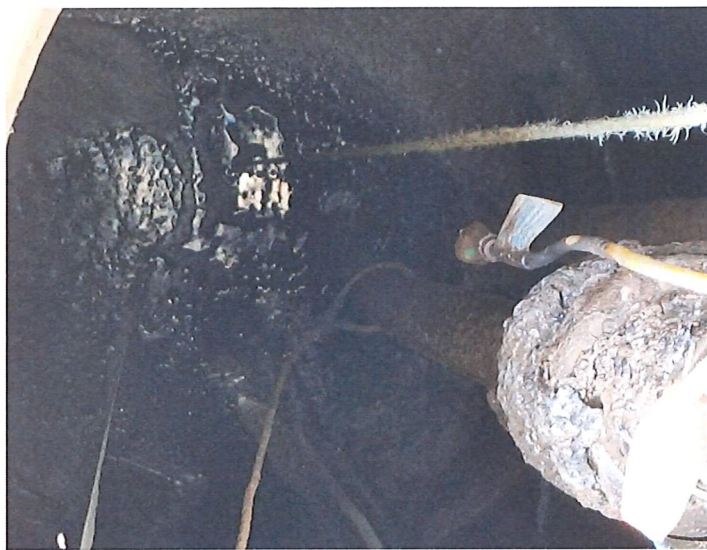
Photo 9: Influent to wet well

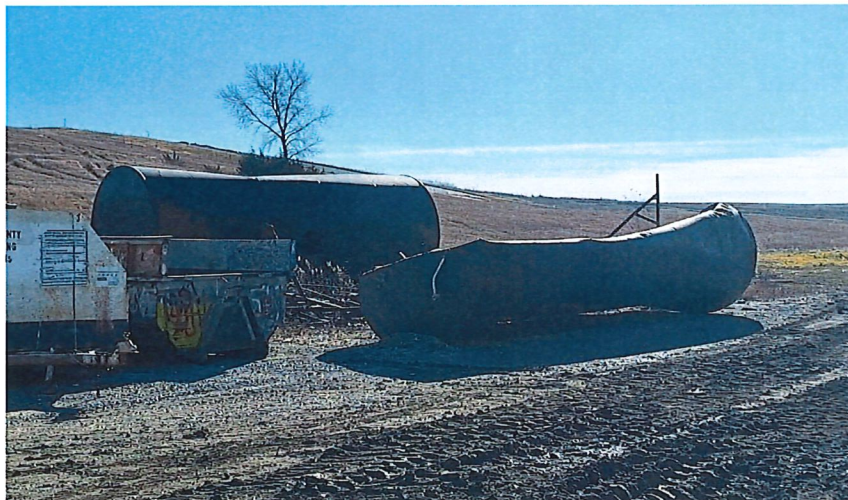
Additionally, Mr. Ward stated that he removed the old leachate holding tanks in September 2024.

Photo 10: Old leachate holding tank

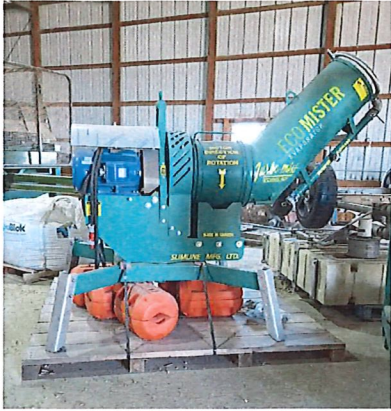
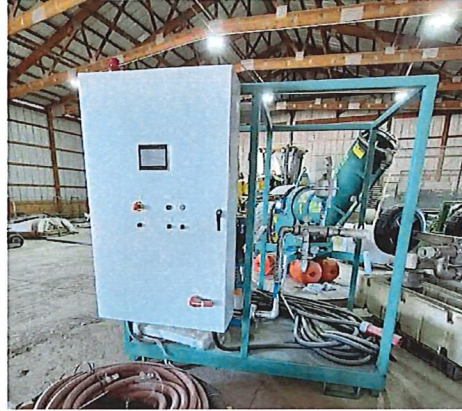
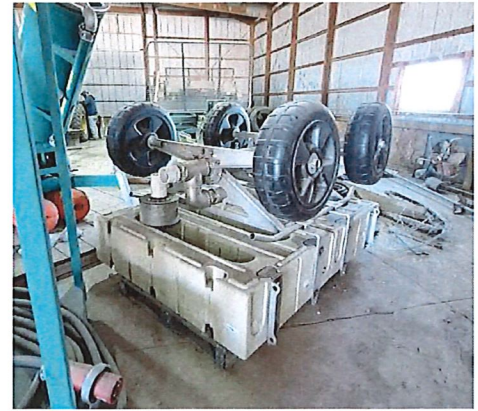
Mr. Ward would like to eventually get to a point where leachate does not need to be transported off site for disposal. As part of the upgrade, the Page County Landfill purchased an EcoMister evaporator that will be

installed in the Spring 2025. There are concrete pads located in the northwest and southwest corners of the lagoon to support the EcoMister. The photos below document the EcoMister.

Photos 11-13: EcoMister
