RE: Audubon County Sanitary Landfill
Spring 2026 Semi-Annual Inspection
IDNR Permit #05-SDP-01-75C
HLW PN 6050

SPRING 2026 INSPECTION

AUDUBON COUNTY SANITARY LANDFILL
AUDUBON, IOWA

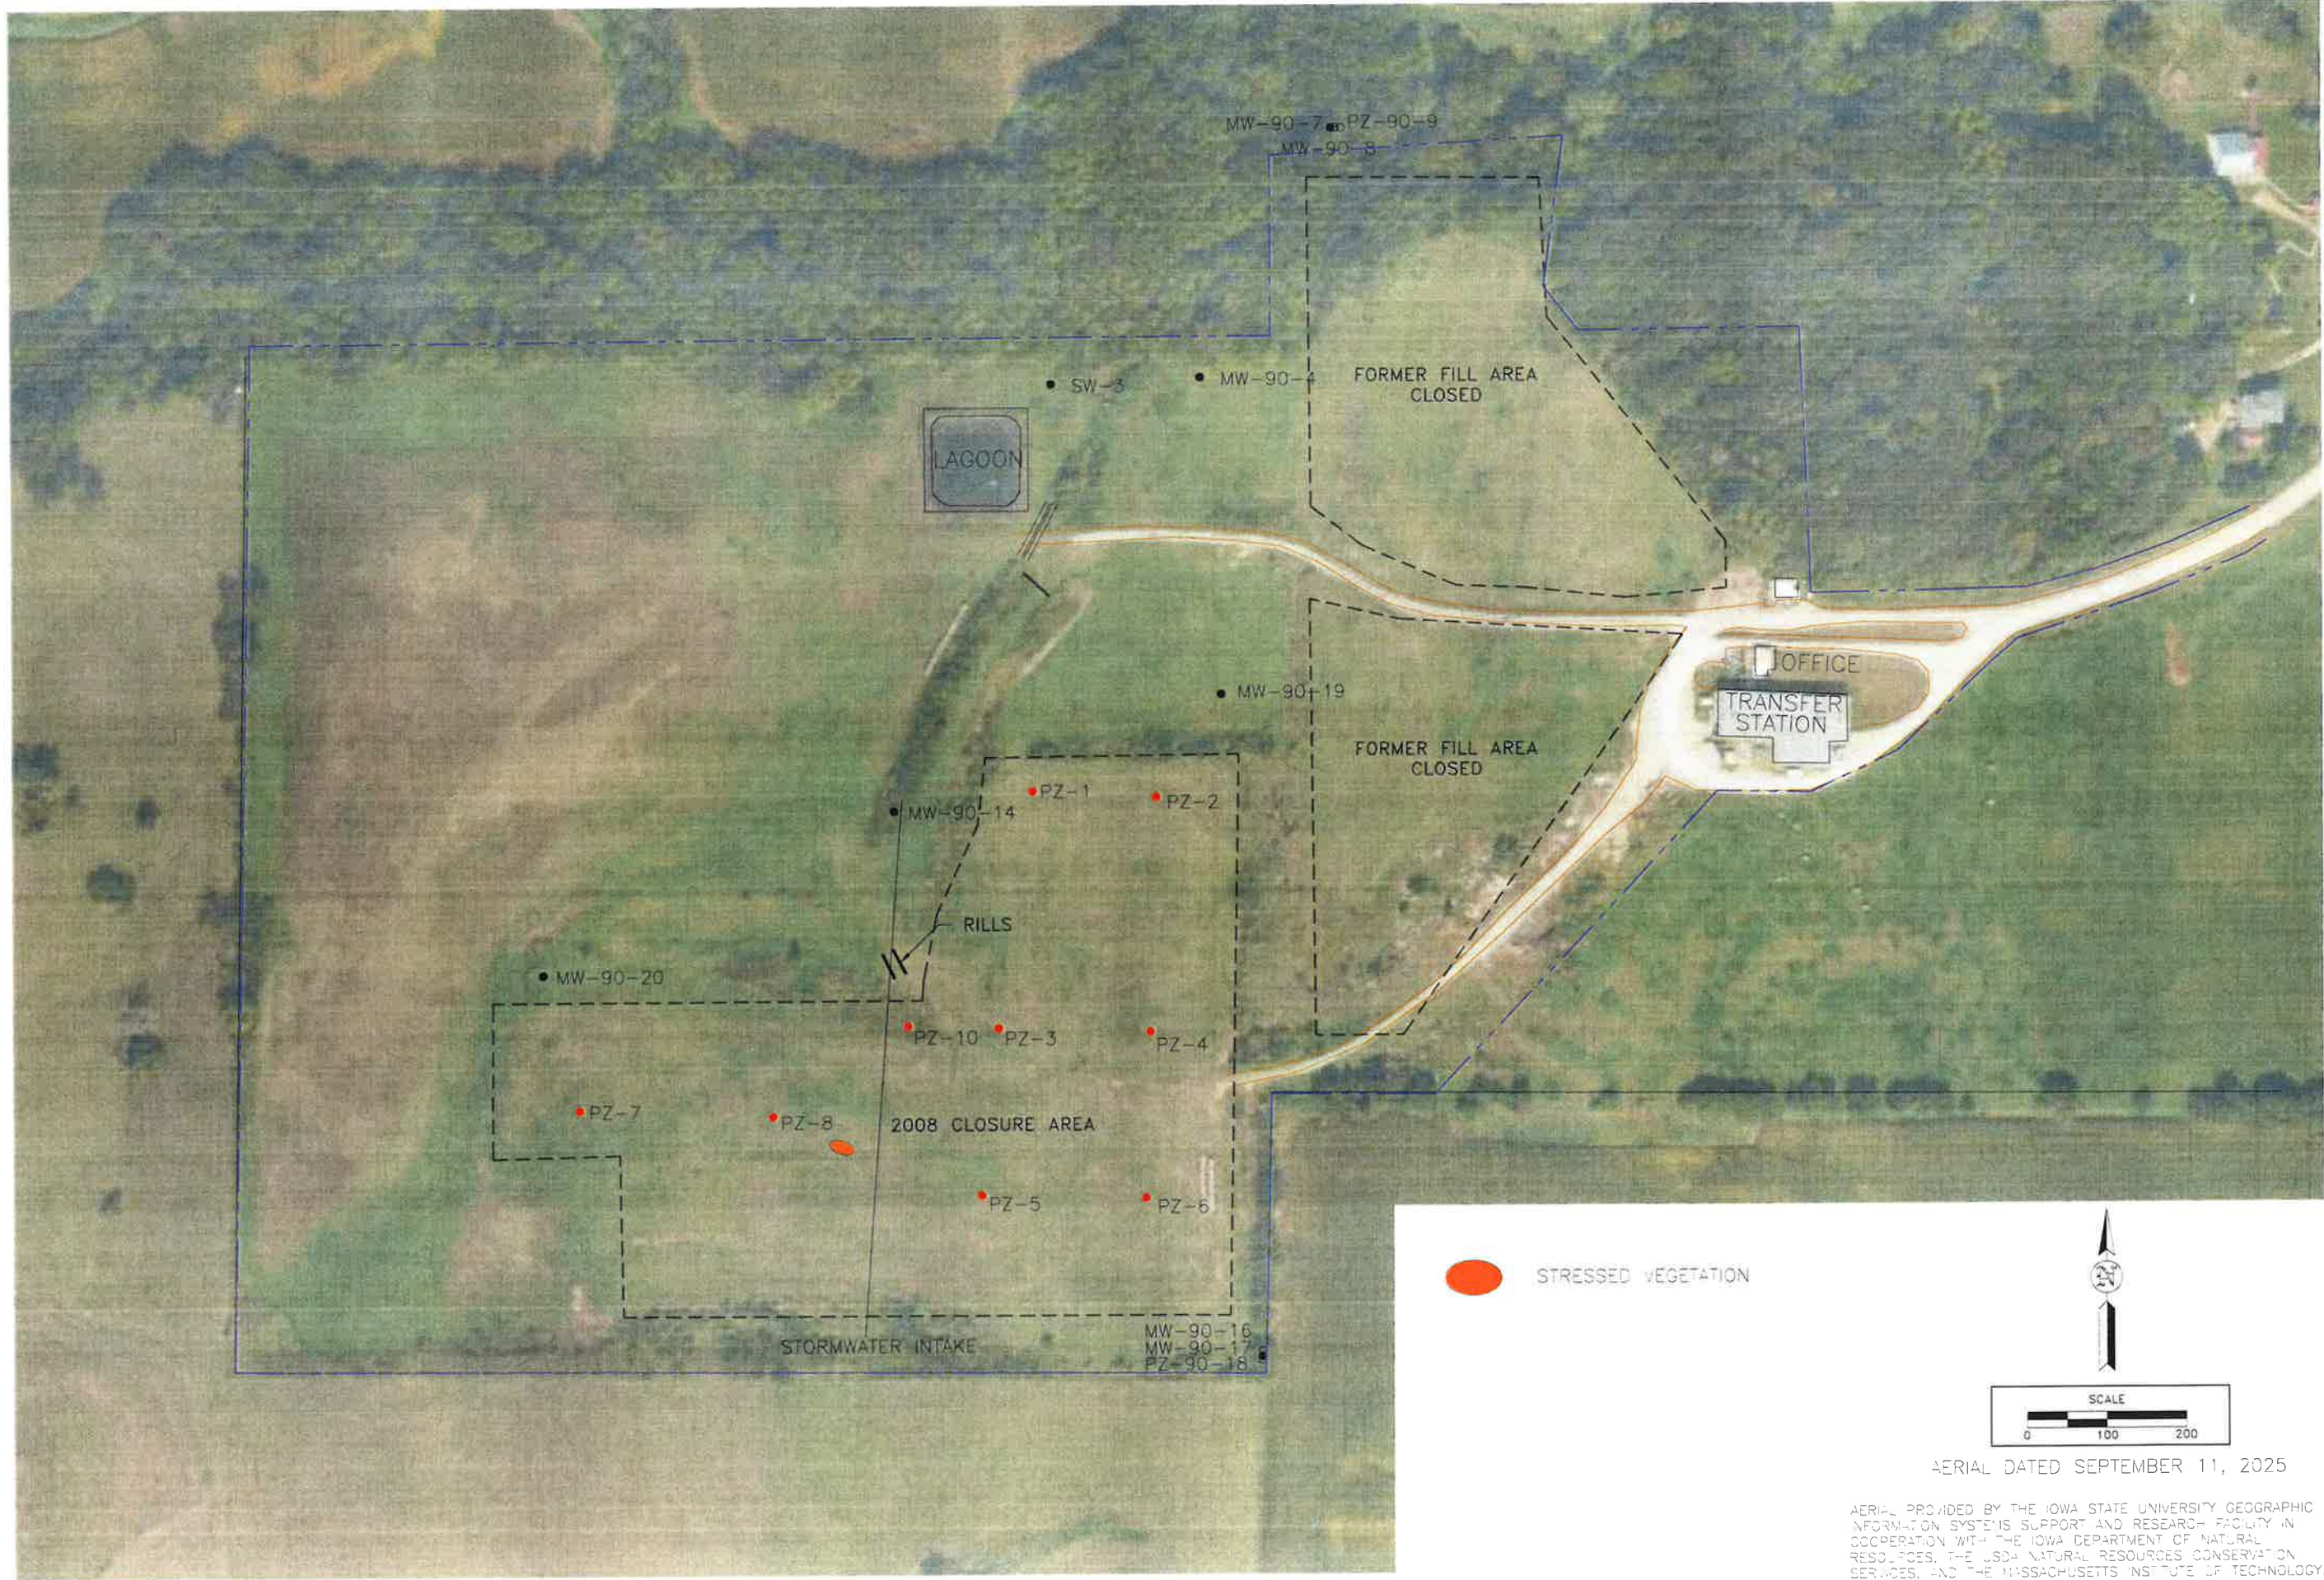
9. Staff reseeds repaired and sparsely vegetated areas as needed. Staff has also used county ditch cleanings and composted yard waste to correct settlement problems in the past. Areas of stressed vegetation between PZ-5 and PZ-6 were reseeded last year and new growth is noted. A small area of stressed vegetation was noted southeast of PZ-8. The approximate location of the stressed vegetation is included on the attached figure.

Two rills have formed near PZ-10; however, the rills are well vegetated and based on the condition of vegetation in this area, the rills do not appear to be active. The rills appear to be outside of the historic waste boundary and no waste is exposed in the rills. The approximate location of the rills is included on the attached figure.

1. Continue tree removal from the cap and around the lagoon as needed and monitor tree growth in the central drainage ditch. If the trees in the ditch hinder surface water drainage have them removed to restore the capacity of the ditch.
2. Continue to monitor area of stressed vegetation southeast of PZ-8.
3. Continue to monitor site vegetation and repair/reseed as necessary.
4. Continue to monitor the vegetated rills near PZ-10.
5. Continue to monitor site erosion, drainage, and diversion systems and repair as necessary.
