Subject: 2026 Annual Inspection Report
Guthrie County Sanitary Landfill
Permit No. 39-SDP-01-73C

This brief report documents the annual inspection required by the Guthrie County Sanitary Landfill (Landfill) Iowa Department of Natural Resources Sanitary Disposal Project Closure Permit, applicable amendments, and the Iowa Administrative Code. The inspection was conducted by Todd Courtney on March 17, 2026, and was performed to evaluate the Landfill's general conformance with the closure permit and the approved plans and specifications. A map of the Landfill is attached for reference (Figure 1). A copy of the observation checklist used during the inspection is included in Attachment A. Please refer to this checklist for specific observations and recommended activities to address areas of concern noted during the inspection. Concerns noted during the inspection were discussed with Site Supervisor Dan Smith at the conclusion of the inspection.

Site Map

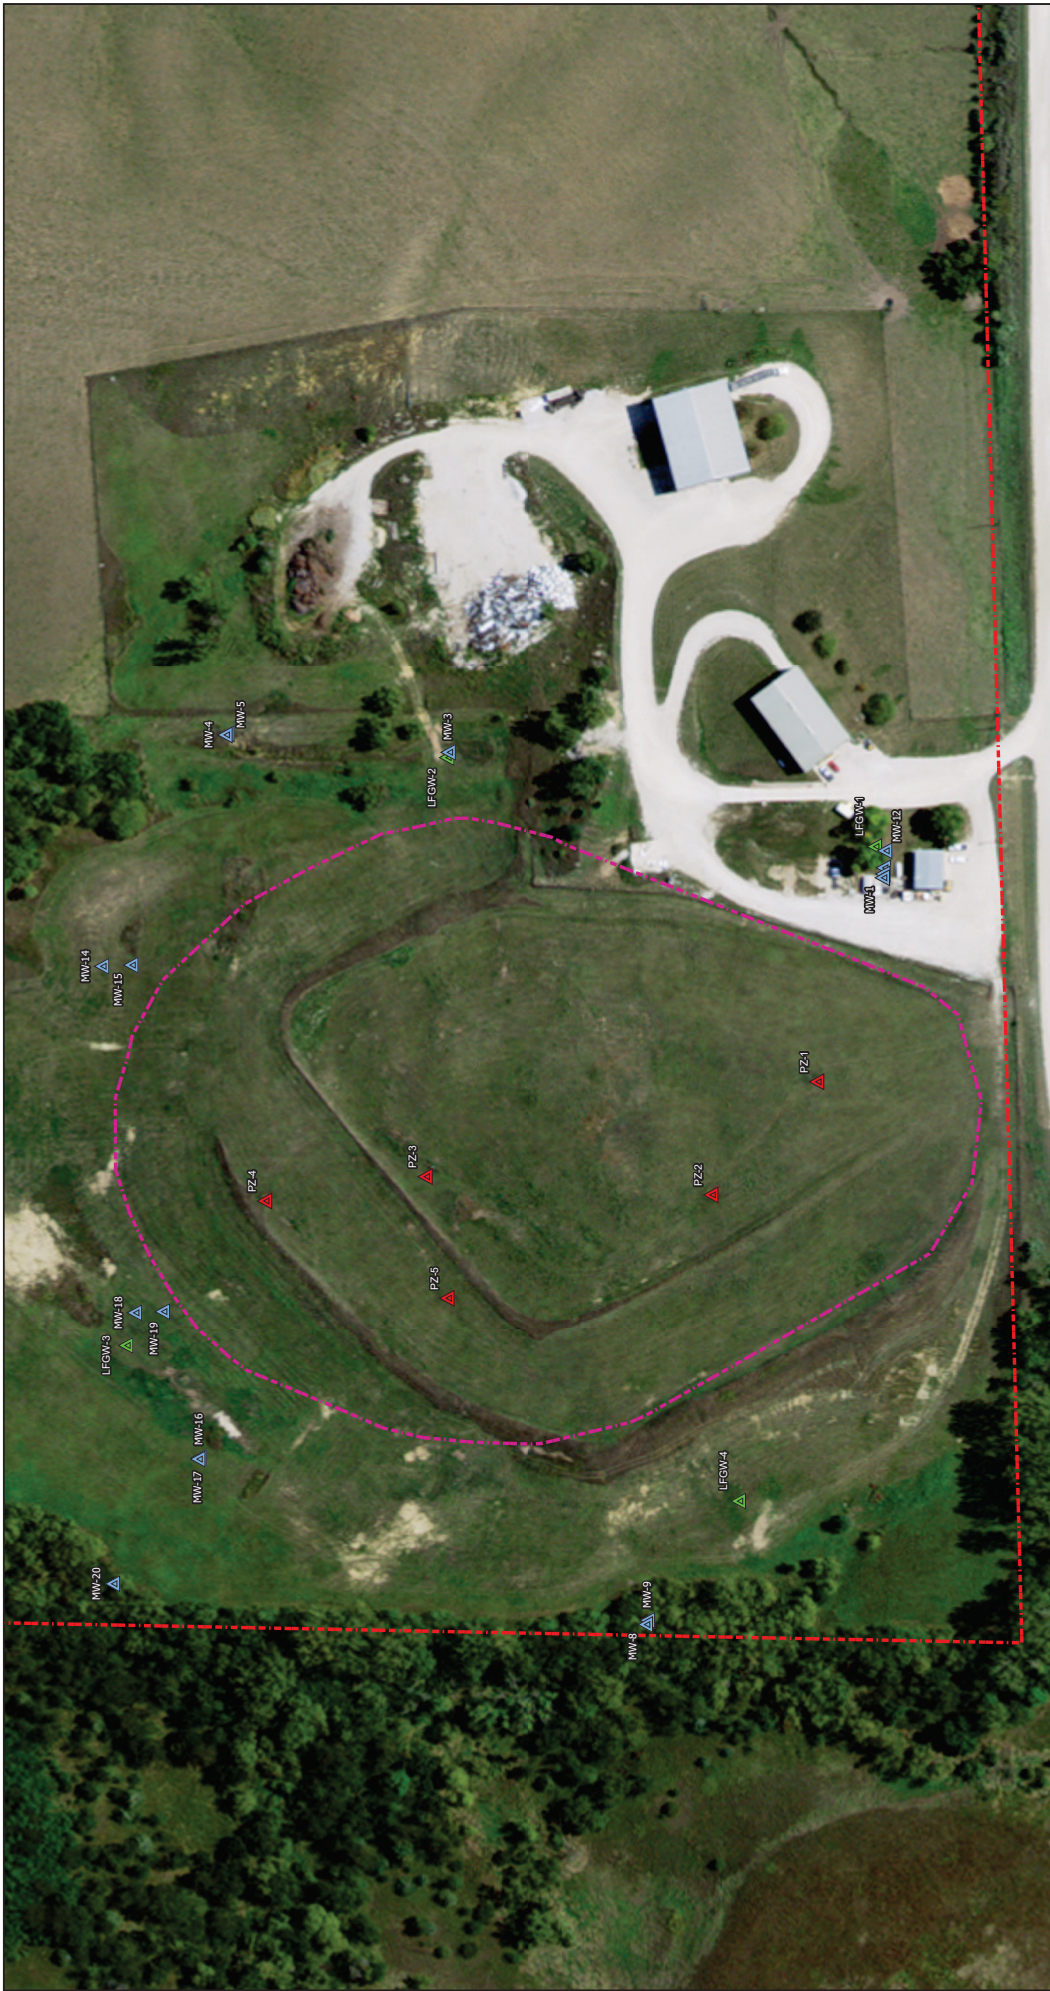
Figure 1

- Legend**
- ▲ Approximate Leachate Piezometer Location
 - ▲ Approximate Methane Monitoring Point Location
 - ▲ Approximate Monitoring Well Location
 - Approximate Waste Boundary
 - Approximate Property Boundary
