RE: Sanitary Disposal Project Inspection  
Tama County Sanitary Landfill, 2872 K Avenue, Toledo, IA  
Sanitary Disposal Project Permit # 86-SDP-01-72P

**IOWA DEPARTMENT OF NATURAL RESOURCES  
Sanitary Disposal Project Inspection**

**Permit #: 86-SDP-01-72P**

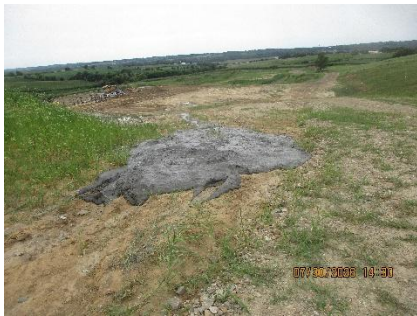
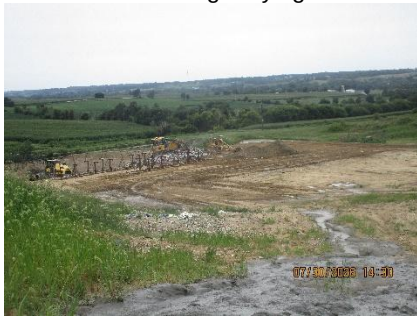
- 12. Survey controls and monuments [See 113.8(2) “a”]:** Operators follow the GPS equipment for identifying waste placement and elevations.
- 15. Special Wastes Managed [See 113.8(2) “e”]:** I observed car wash sludge on piles for drying above the current working face. Liquid runoff paths were emanating from the piles. This material may be treated as the general special waste category, which includes stabilized grit, bar screenings, and grease skimmings [567 IAC 109.11(3)] (excluding item b.):

This requires the sludge to pass the paint filter test. If it does not pass, a permit amendment would be necessary to allow for solidification on-site. If it does pass this test, the landfill may develop its own special waste acceptance criteria (SWAC) in lieu of the guidelines listed above.

car wash sludge drying area

- Ensure that car wash sludge passes a paint filter test. If it does not, obtain a permit amendment to allow for solidification on-site. If it does, follow the general special waste handling procedures for stabilized grit, bar screenings, and grease skimmings (excluding item b.) [567 IAC 109.11(3)], or develop special waste acceptance criteria (SWAC) for this material.
- Monitor finished areas with dead vegetation for possible gas ventilation and take remedial action as deemed necessary.

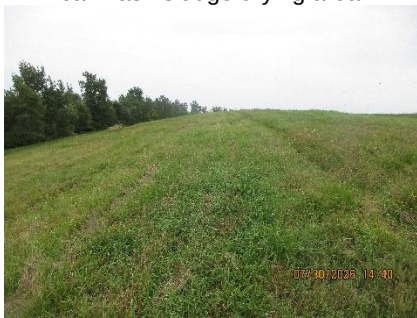
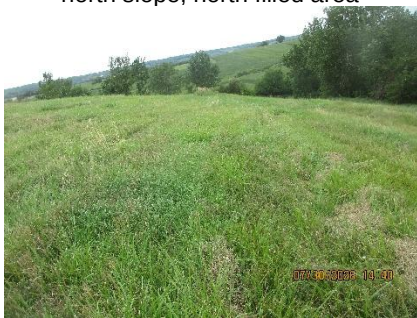
north slope, north filled area

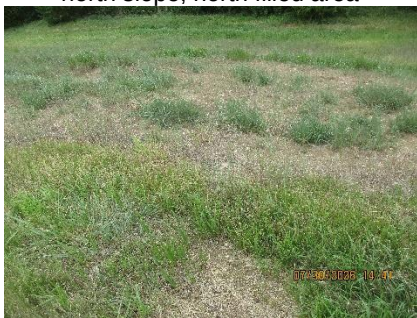
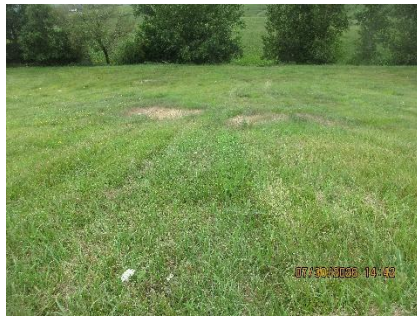
- 28. Final cover system control [See 113.12(455B)]:** The north and east filled areas had good vegetative cover except for a few spots that were bare or sparse. This could be the result of gas ventilation. If so, installation of gas control mechanisms should be considered.

bare spots in north filled area

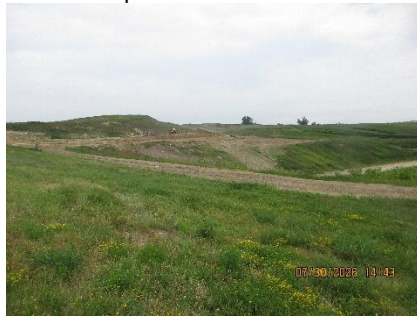
west side, north filled area

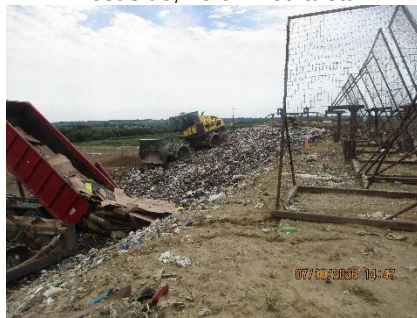
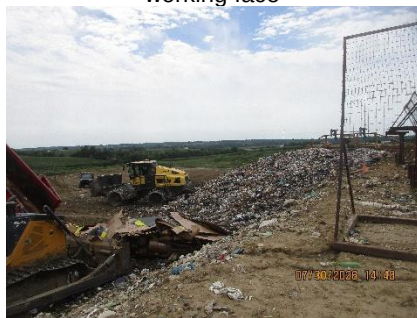
- 16. Cover/Alternative cover material adequate [See 113.8(2) “f”]:** Daily and intermediate cover was not adequate during an inspection in 2025. Cover was adequate during this inspection and during a site visit in January. Daily cover was being achieved using a tarp on the face and soil on top.

working face

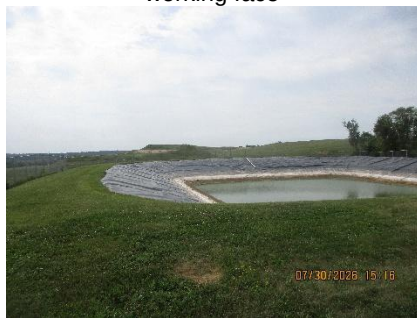
- 22. Leachate collection [See 113.7(5)“b”] and treatment [See 113.8(3) “i”]:** Leachate head measurement show the twelve-inch maximum was being met (greatest leachate thickness in 2026 has been five inches). The leachate lagoon was nearly empty. Records show 161,700 gallons were recirculated in the active landfill in 2025, and 459,900 gallons so far in 2026. Records show 738,813 gallons were hauled to the Toledo wastewater treatment plant in 2025, and 348,897 gallons so far in 2026. A treatment agreement with Toledo has a November 2, 2027, expiration date.

leachate lagoon

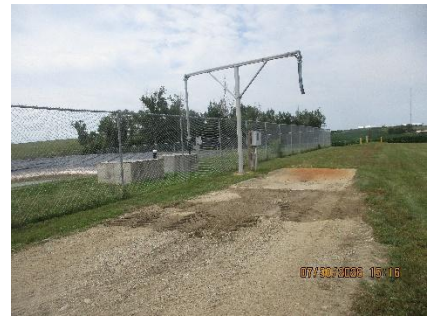
leachate loading rack
