Subject: Sanitary Disposal Project Inspection  
Permit # 95-SDP-01072

**IOWA DEPARTMENT OF NATURAL RESOURCES**  
**Sanitary Disposal Project Inspection**

Permit #: 95-SDP-01-72P

Facility Name: Central Disposal Systems, Inc

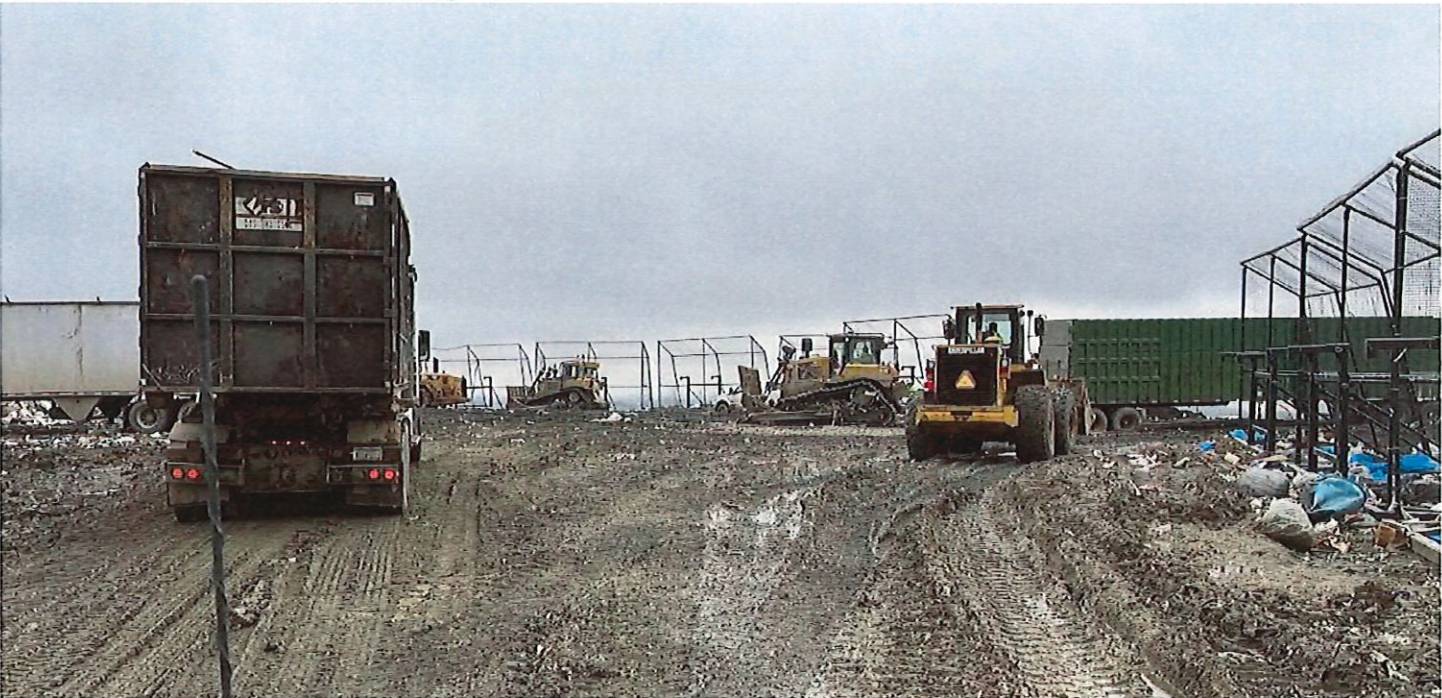
Photo 1. New Litter Fences at Working Face

Item 14c – Working Face – Mr. Reynolds reported that 15 new mobile screens have been purchased. Screens were in use at the working face at the time of inspection (photo 1).

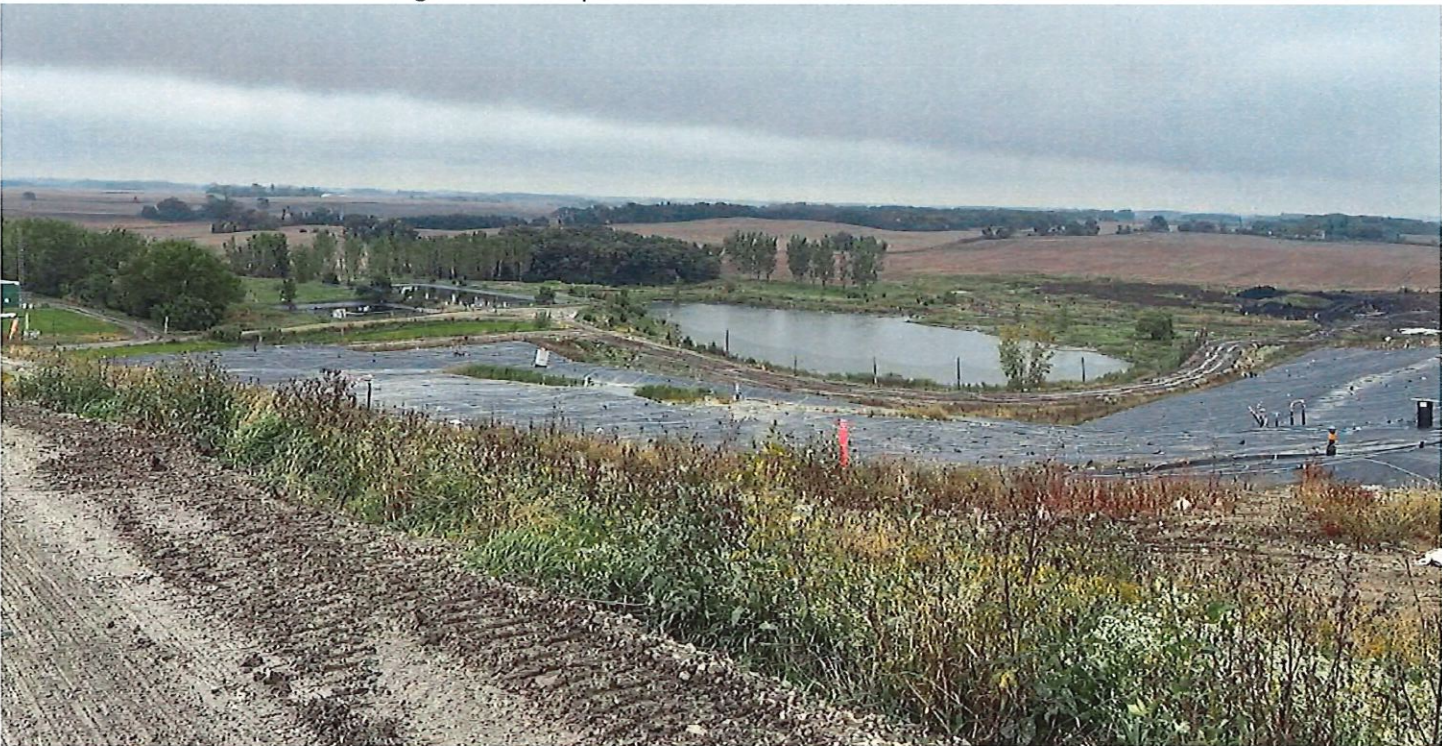
Photo 2. New 20' litter fences along stormwater pond

Item 16 – Waste Fill Cover – Soil and tarp are being used for daily cover. A synthetic intermediate cover is in place north of the stormwater pond (photo 2).

Item 19 – Site Litter Control – Litter control was excellent at the time of the inspection. Mr. Reynolds reported that 1400' of 20' netting has been purchased. The netting is installed around the stormwater pond with additional netting to be installed along the road north of the stormwater pond (see photo 2). In addition, 2000' of 6' fence has or will be installed. Litter picking records are being maintained on-site.
